Eastern embankment approach to Bermuda Bridge

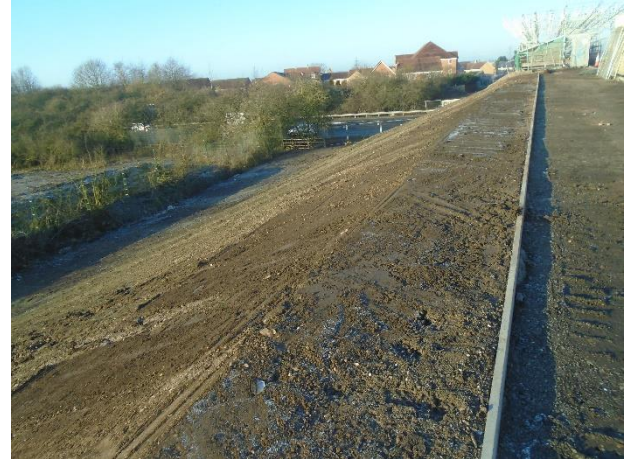
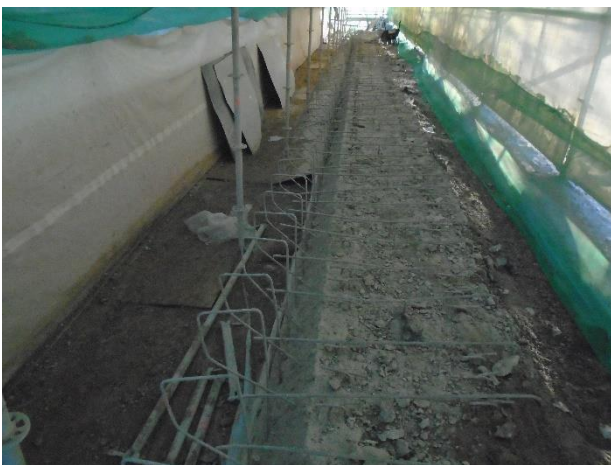
Top soiling to the eastern embankment approach to Bermuda Bridge has been completed

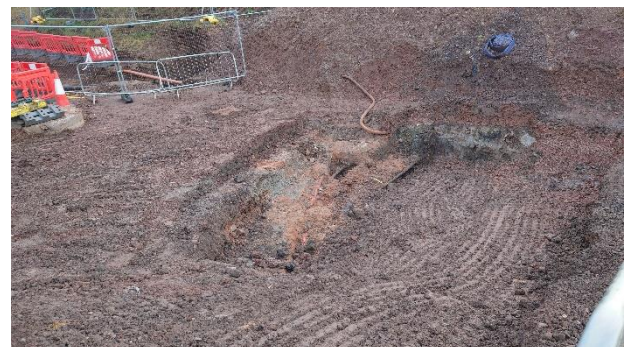
Gas Vent Trench Exposure Works

The existing Gas Vent Trench (GVT) which is located adjacent to the housing developments in the vicinity of The Bridleway is required to be extended to new ground levels and has been exposed to ascertain size, line, and level. Design work is completed and GVT extension works are planned to commence in February.

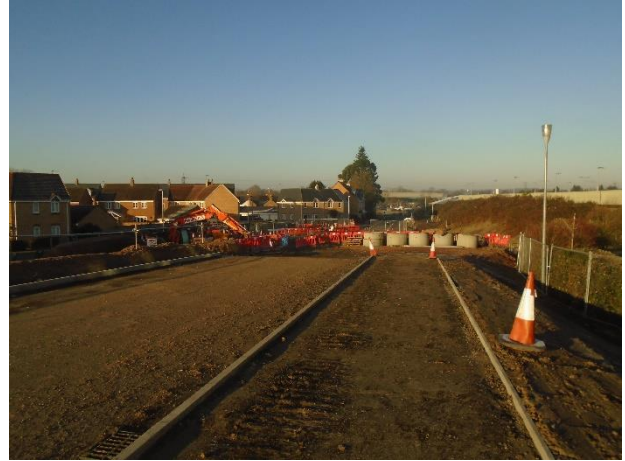
Western embankment approach to Bermuda Bridge

Works to the western embankment approach to Bermuda Bridge are continuing where the works are not affected by the ongoing works on the GVT
