Section 19 Flood Investigation

Flooding 14/15 November 2019

Warwickshire County Council as Lead Local Flood Authority

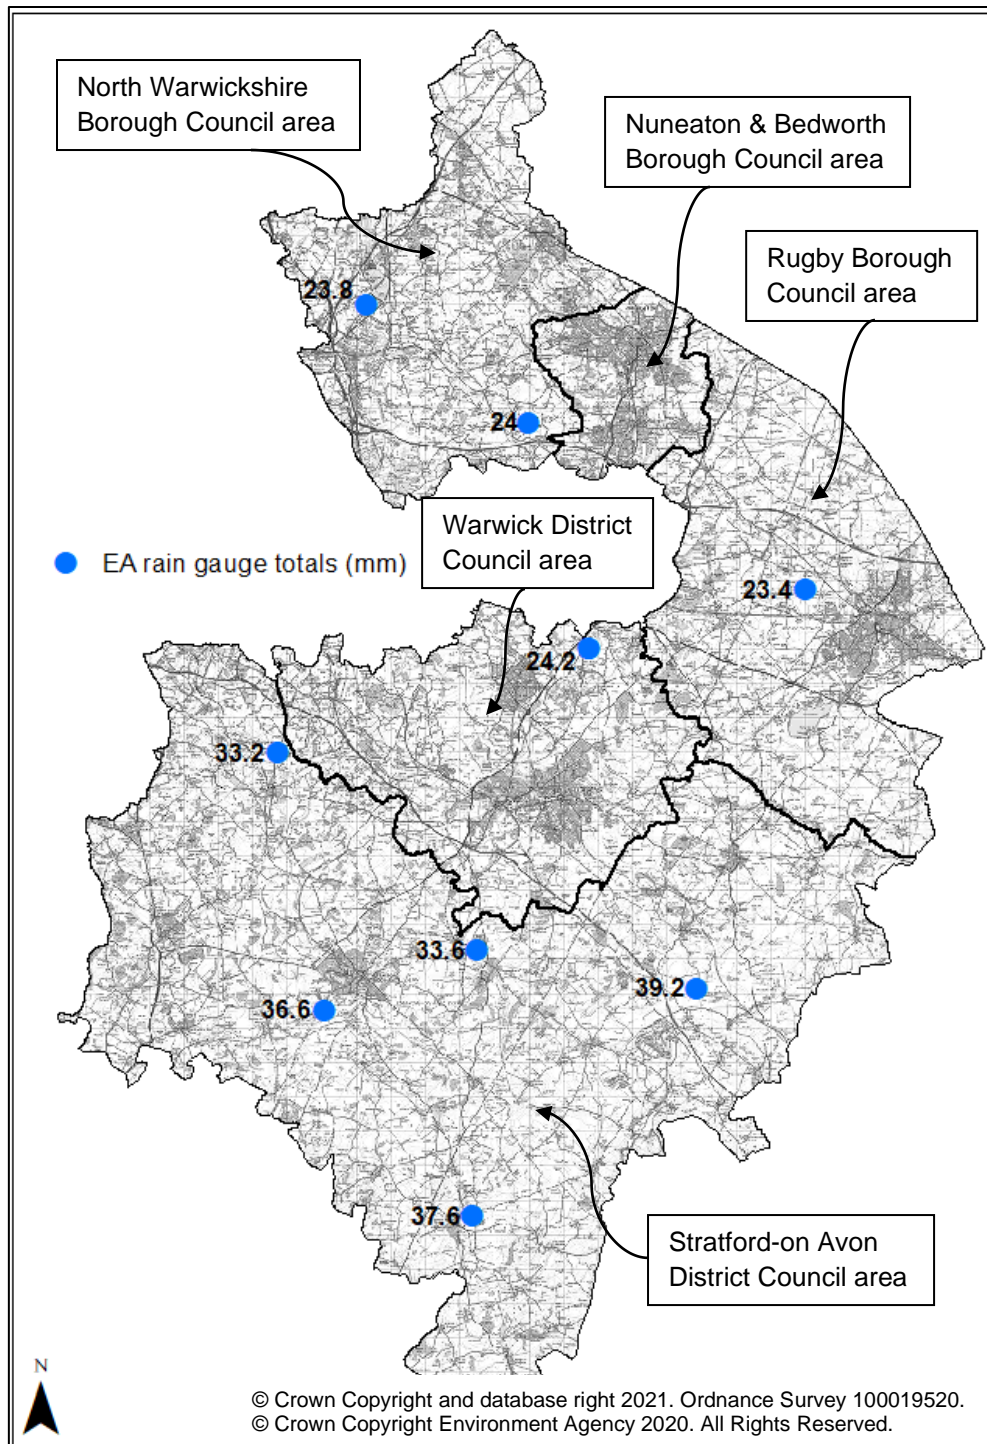
Figure 1: Map of Warwickshire and District/borough boundaries showing 48 hr rainfall accumulations in Environment Agency rain gauges on the 14/15 November 2019.

From the early hours of the 14 November, a weather front brought a band of rain across Warwickshire which persisted for most of the day. The rain was generally heavier across southern parts of the county where the largest rainfall totals occurred. As shown in Figure 1 below, parts of the county received 39 mm of rain during this event, which is 60% of the average rainfall expected for the entire month⁴.

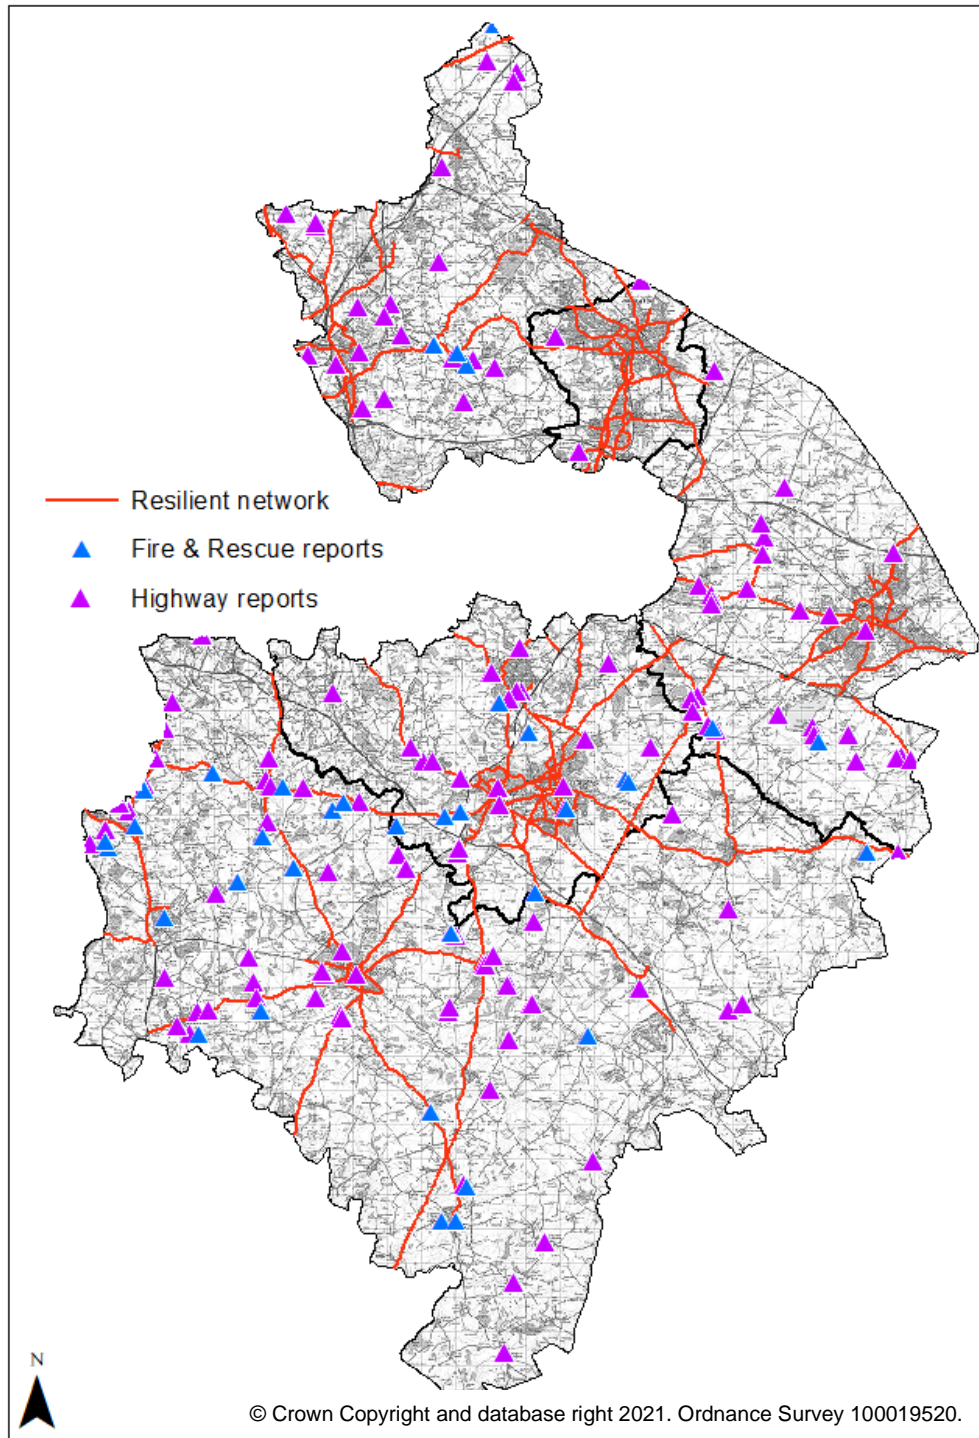
Figure 3: Map of Warwickshire and District/borough boundaries showing locations of the WCC highway resilient network, WCC highway flood reports and Warwickshire Fire & Rescue service water rescues on the 14/15 November 2019.

Figure 3 shows the 40 locations where Warwickshire Fire and Rescue Service attended a water rescue call-out, such as a vehicle stranded in flood water on the highway. These were mostly in the south of the county.

Also shown on Figure 3 is the highway resilient network. This network shows the stretches of WCC highway which are given priority during extreme weather to maintain economic activity and access to key services. A total of 43 of all highway or fire and rescue reports occurred on the resilient network.

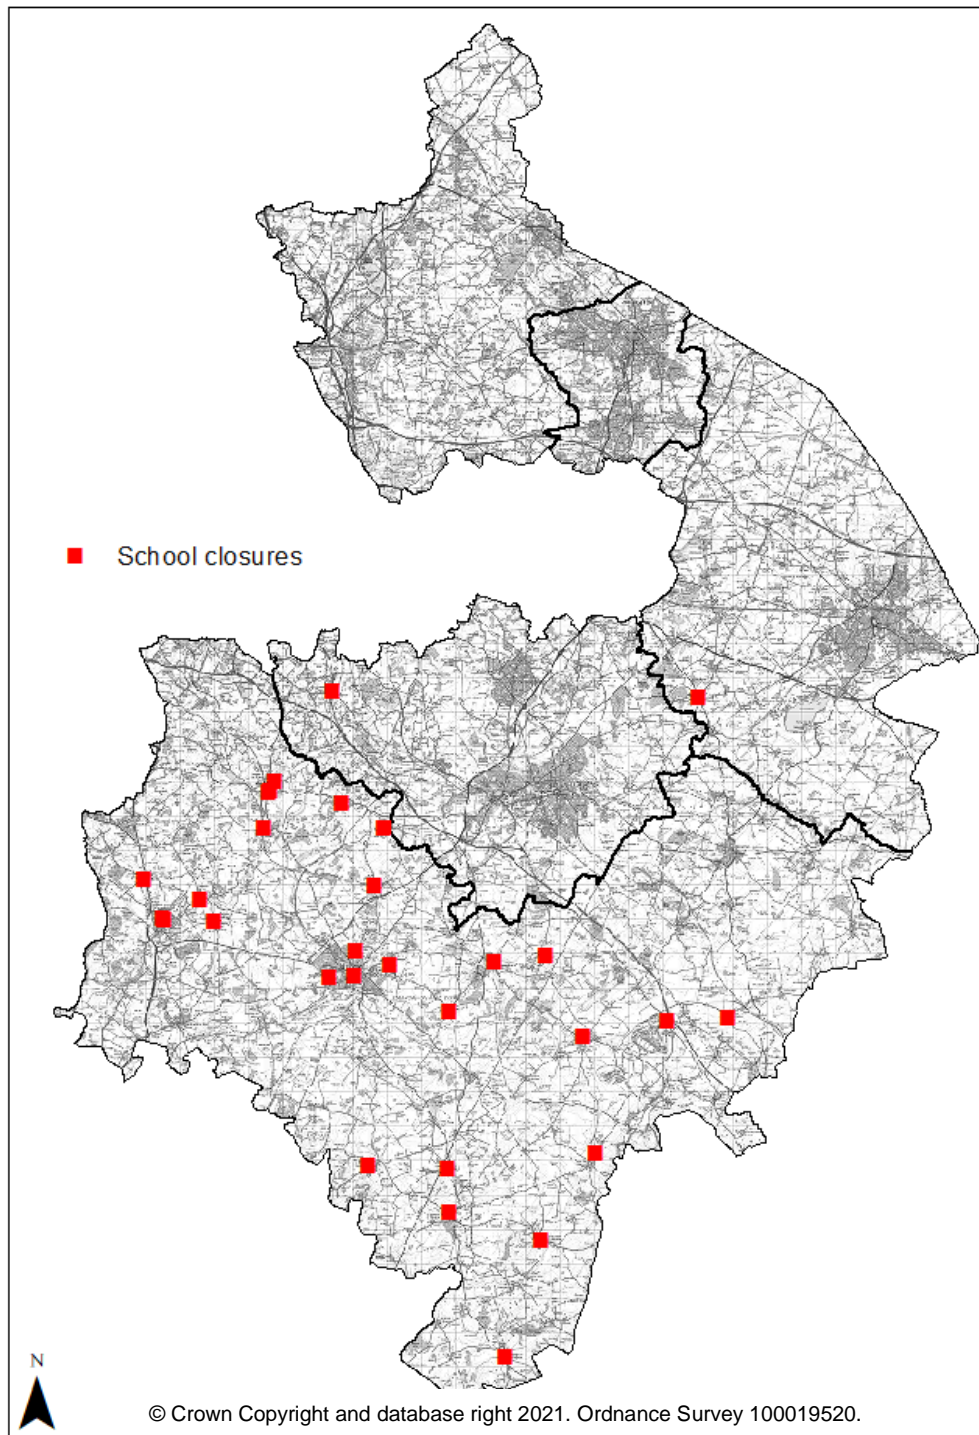
Figure 4: Map of Warwickshire and District/borough boundaries showing locations of closed schools due to flooded access on the 14/15 November 2019.

There were 28 emergency school closures across the county as staff and students were unable to safely access the schools due to flooding to the highway or external areas of the school grounds. The distribution of these schools is shown in Figure 4.

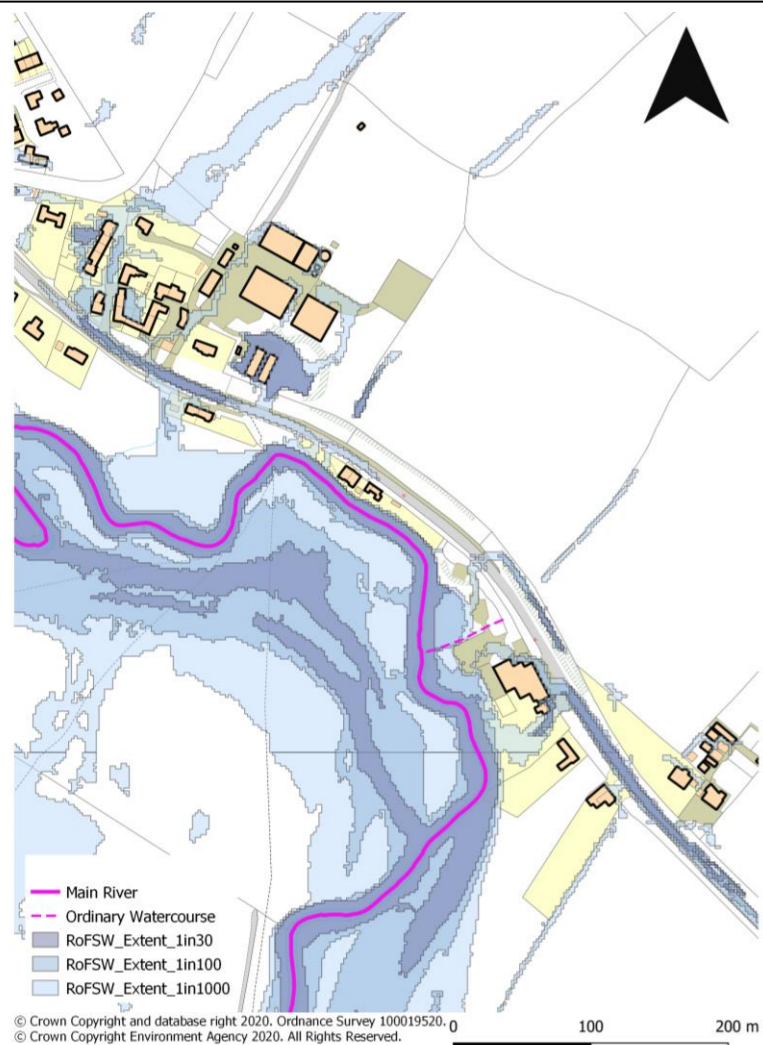
The remaining flows continued north-westwards before entering the Stour by means of a similar area of dropped kerb associated with a car parking area. During the event water had welled up from beneath the floor flooding the properties to several centimetres. There are anecdotal reports that an old and damaged land drain may flow beneath the properties, however no records exist to confirm the existence of such a feature.

It is notable that significant ditching works have been undertaken in the land above the affected properties which may have channelled flows towards the highway. It should be noted that the works undertaken appear to have been undertaken as maintenance works and are not newly constructed features.

- Historic reports of water ingress to one property resulting from a damaged highway drain. This line has now been abandoned and outfalls elsewhere away from the property.
- A second flood event was subsequently reported (9th January 2020) by one of the same properties affected in November and a business property flooded by a similar mechanism. It was reported that significant volumes of water were impounded behind a flood defence wall within the garden of the property eventually exceeding the threshold level of the property, causing internal property flooding and resulting in the failure of the flood wall.

No.	Action	Responsible authority	Progress
1	Establish condition/connectivity of culvert under carriageway that takes field drainage.	WCC LLFA	Complete
2	Ensure that highway cyclic gully cleansing is scheduled at an appropriate interval on Shipston Road.	WCC Highways	Complete – embedded as business as usual
3	Advise resident to consider investigating the presence of a private land drain and undertaking repairs as appropriate.	WCC LLFA	Complete
4	Undertake appropriate checks to ensure culverted system under the public highway and private land on the south eastern edge of the village is suitably maintained following recent ditching activities.	WCC Highways WCC LLFA	Ongoing
5	Offer advice to residents that have been internally flooded from this event	WCC LLFA	Complete
6	Reprofiling of highway verge/accesses adjacent to affected properties to redirect flows / additional drainage	WCC Highways	Complete

7	Offer eligible residents access to the Defra Property Flood Resilience grant	SDC	Complete – 2 properties took up offer of PFR grant

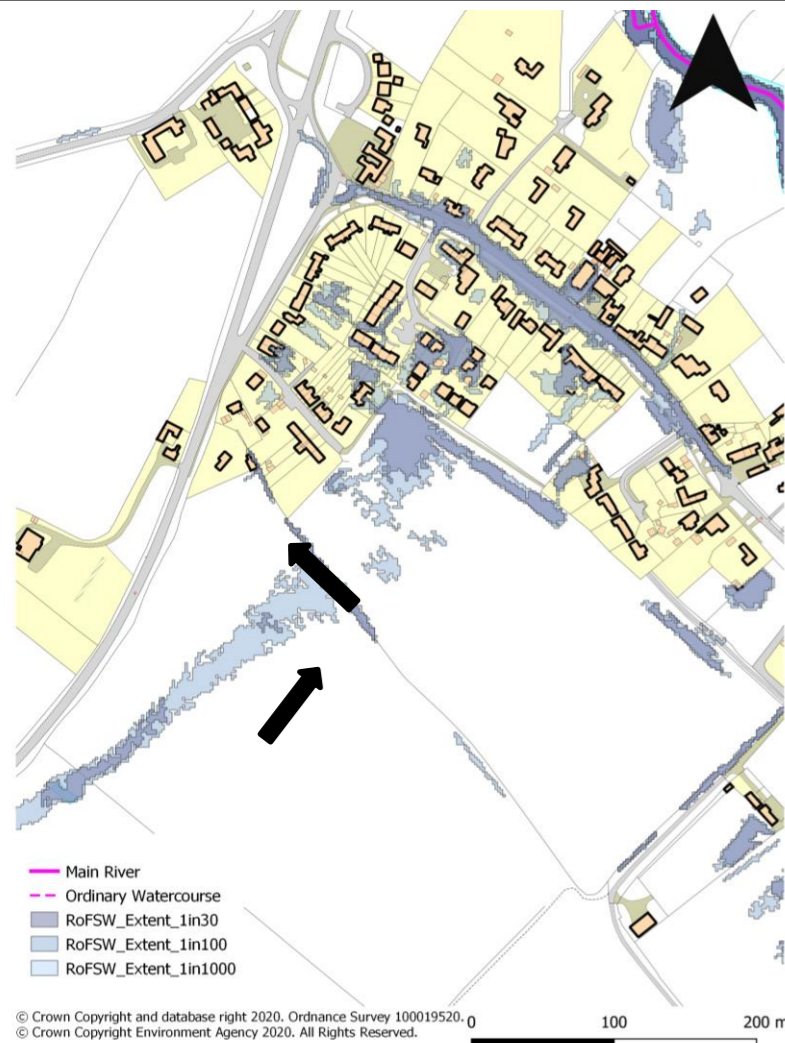
Due to saturated ground conditions, heavy rainfall generated overland flows across Martins Hill which is situated to the south of The Nashes. The volume of water entering the ditch from Martins Hill exceeded the capacity of the ditch and overtopped. Water entered the gardens of numerous properties and eventually led to internal flooding of properties.

To the East of The Nashes is an allotments site that like Martins Hill to the south, was already saturated due to the volume of rainfall. Surface water flows again made their way off the allotments and entered The Nashes flooding the road as well as numerous other properties internally.

In total, four properties along The Nashes and one property further into Clifford Chambers near Barn Close internally flooded.

No.	Action	Responsible authority	Progress
1	Continue to progress with works to deliver a Property Flood Resilience scheme in Clifford Chambers in 2022-2023	WCC LLFA	Ongoing – Outline Business Case approved by EA
2	Offer advice to residents that have been internally flooded from this event	WCC LLFA	Complete
3	Remind local landowners of their riparian duties to maintain watercourses	WCC LLFA	Complete
4	WCC to explore wider drainage issues within Clifford Chambers to see if there are opportunities to reduce the flood risk	WCC LLFA	Ongoing
5	Offer eligible residents access to the Defra Property Flood Resilience grant	SDC	Complete – 1 property took up offer of PFR grant

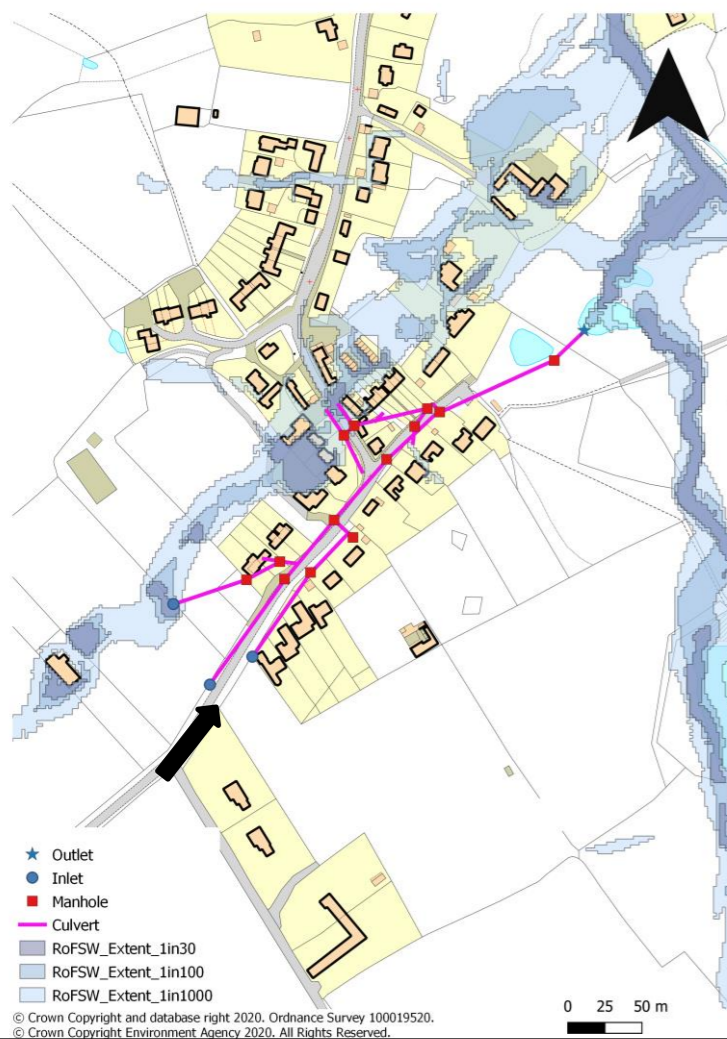
Following heavy rainfall it is reported that surface water flows entered the highway (Goldicote Road) from land south-west of the village (see indicative flow arrow on map). The resulting flows overwhelmed the highway drainage, flowing northward and down Manor Drive. It was reported that flows surcharged from a chamber on Goldicote Road. This chamber was inspected post-flood event and noted to be holding water, suggesting a blockage or similar issue in the downstream system. This flow path is not shown on the EA RoFSW map (left).

Internal flooding occurred to one property located in the resulting surface water flow path. It is reported that whilst water did not breach the threshold of the property, it appeared to have risen through the floor.

No.	Action	Responsible authority	Progress
1	Ensure that highway cyclic gully cleansing is scheduled at an appropriate interval on Goldicote Road.	WCC Highways	Complete – embedded as business as usual
2	Investigate why system on Goldicote Road is not flowing effectively.	WCC Highways	Complete
3	Offer advice to residents and business owners that have been internally flooded from this event	WCC LLFA	Complete
4	Offer eligible residents access to the Defra Property Flood Resilience grant	SDC	Complete – 0 properties took up offer of PFR grant

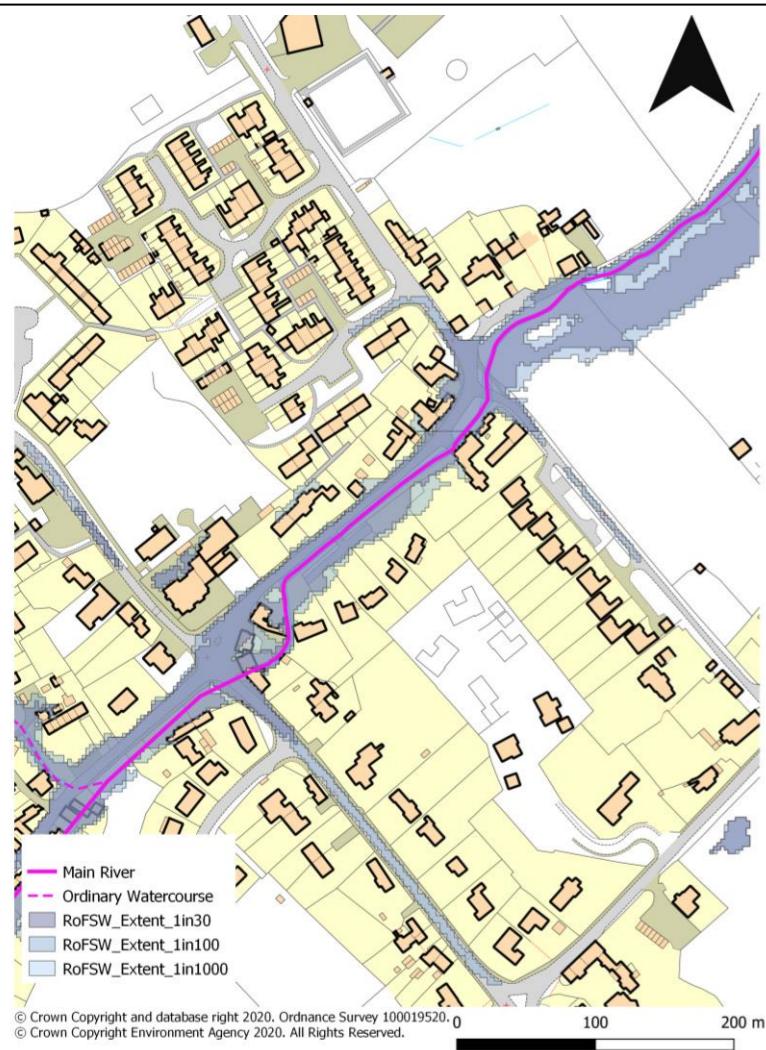
Following a period of heavy rainfall, the river level in the Bell Brook rose significantly. This prevented the highway drainage surface water system from discharging into the Bell Brook as it would during normal conditions. The Bell Brook then burst its bank leading to further highway flooding and overwhelmed the foul sewer system causing this to back up leading to internal property flooding.

In close proximity to School Lane are a number of steep roads including Bell Lane, Wolverton Road, Smiths Lane and Bearley Road. Any water that fell on these stretches of highway ran down towards the low point of the village (School Lane) and began to collect around the already full Bell Brook.

In total 5 properties were flooded internally, some to depths in excess of 15 centimetres.

No.	Action	Responsible authority	Progress
1	Ensure that highway cyclic gully cleansing is scheduled at an appropriate interval on School Lane	WCC Highways	Complete – embedded as business as usual
2	Carry out a CCTV Survey from manhole 3801 down towards manhole 4001 in the vicinity of the primary school and School Road to investigate foul drainage issues	STW	Complete
3	Progress with works to carry out a modelling exercise of the Bell Brook from Smith's Lane to downstream of the two ponds east of Snitterfield	EA	Ongoing
4	WCC LLFA to work with residents group to investigate options to reduce flood risk within the village, ensuring riparian duties are met.	WCC LLFA	Ongoing – frequent engagement with community
5	Severn Trent Water to consider whether options exist to reduce the risk of sewer flooding here in the future.	STW	Ongoing
6	Offer eligible residents access to the Defra Property Flood Resilience grant	SDC	Complete – 0 properties took up offer of PFR grant

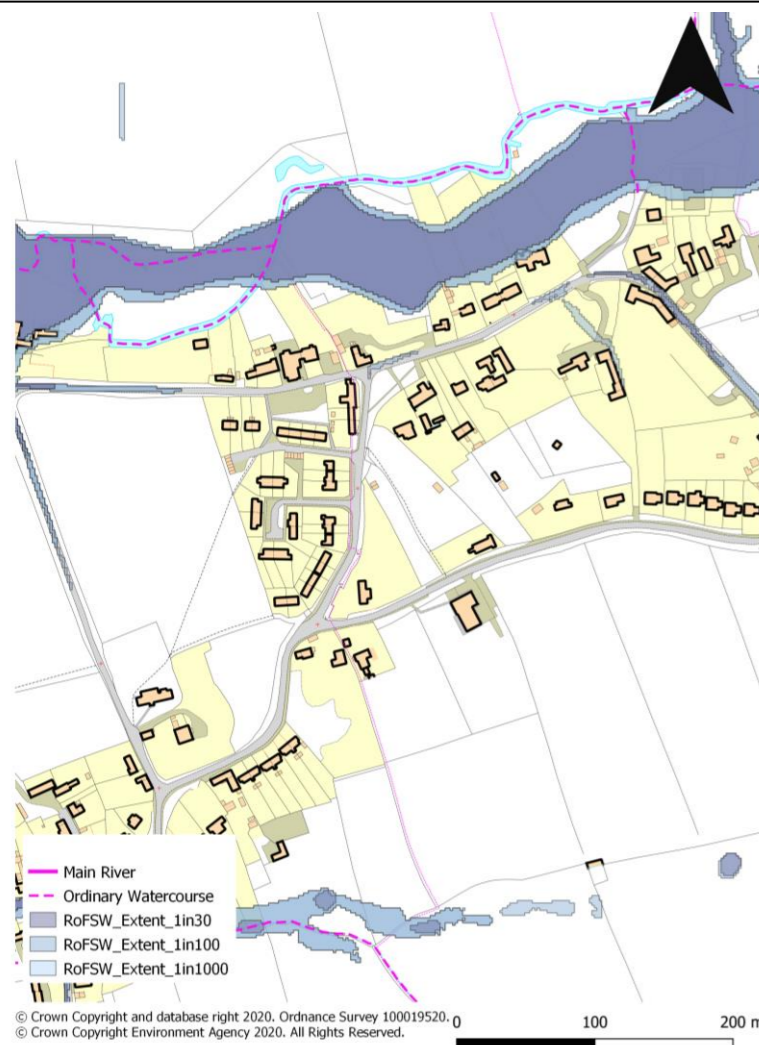
It is likely that flood water managed to enter properties through openings (such as doors, air bricks and waste pipes), floors and walls.

Some properties reported flood water affecting their frontages which may have been due to a combination of high groundwater levels from the Stour in flood and also surface water runoff from the highway. The highway itself was reportedly flooded.

No.	Action	Responsible authority	Progress
1	Advise residents to review the effectiveness of existing Property Flood Resilience and explore any additional measures.	WCC LLFA	Complete
2	Ensure that highway cyclic gully cleansing is scheduled at an appropriate interval.	WCC Highways	Complete – embedded as business as usual
3	Offer eligible residents access to the Defra Property Flood Resilience grant	SDC	Complete – 0 properties took up offer of PFR grant

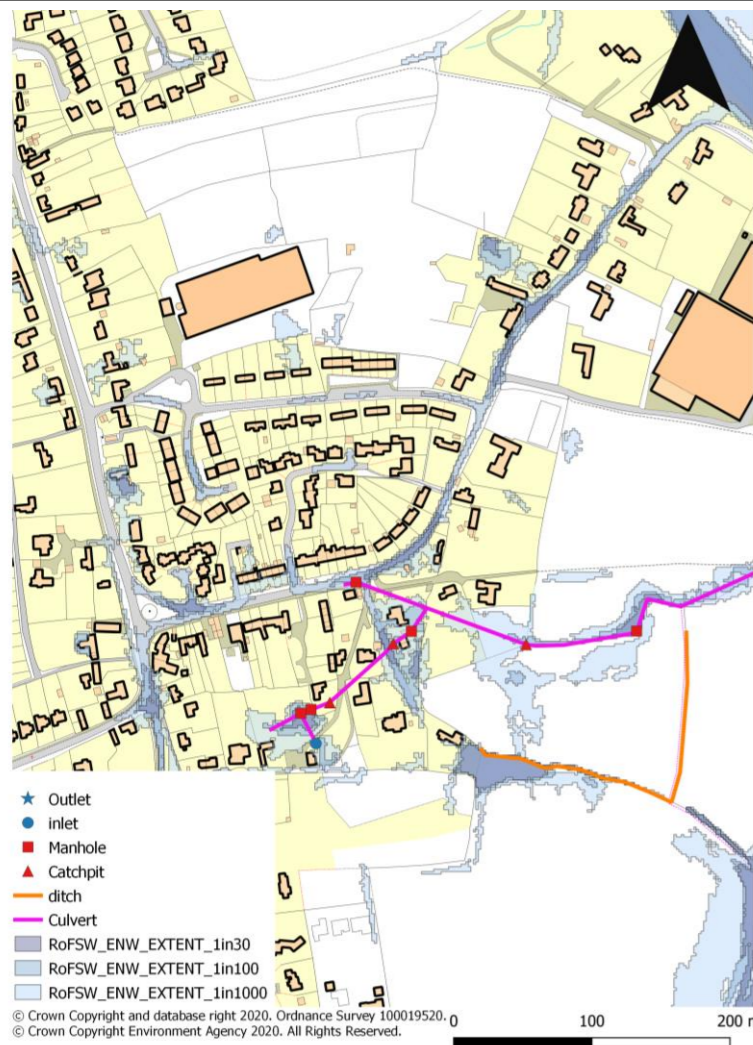
Following a period of heavy rainfall, and wet weather subsequent to this, the land to the south-east of Pool Close quickly became saturated. These conditions subsequently began to flood the gardens of some of the properties in Pool Close and eventually overwhelmed the piped drainage system which carries flows eastwards away from the area.

7	Offer eligible residents access to the Defra Property Flood Resilience grant	SDC	Complete – 0 properties took up offer of PFR grant
