## Section 19 Flood Investigation

Flooding 11<sup>th</sup> June 2023 Wood End, Atherstone

Warwickshire County Council as Lead Local Flood Authority

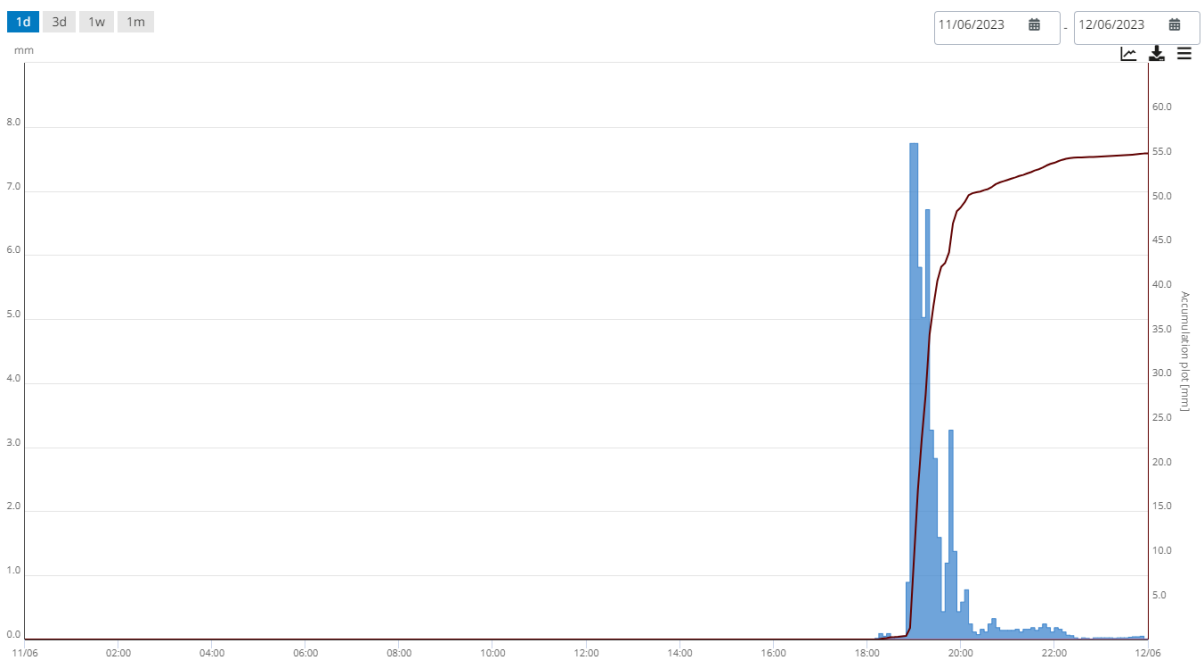
Figure 1, Wood End rainfall accumulations, source Hydromaster, data DTN

Rainfall radar data for Wood End obtained through Hydromaster, a software which WCC utilises which provides real time and historic rainfall data from the Met Office, shows that during the period of the 11<sup>th</sup> June 2023, a daily rainfall total of 54.92mm fell. Peak rainfall rates were observed between 20:00 and 00:00hrs. Within the wider catchment stretching from the River Blythe to the River Anker, Hydromaster records a daily total rainfall of 35.41mm fell.

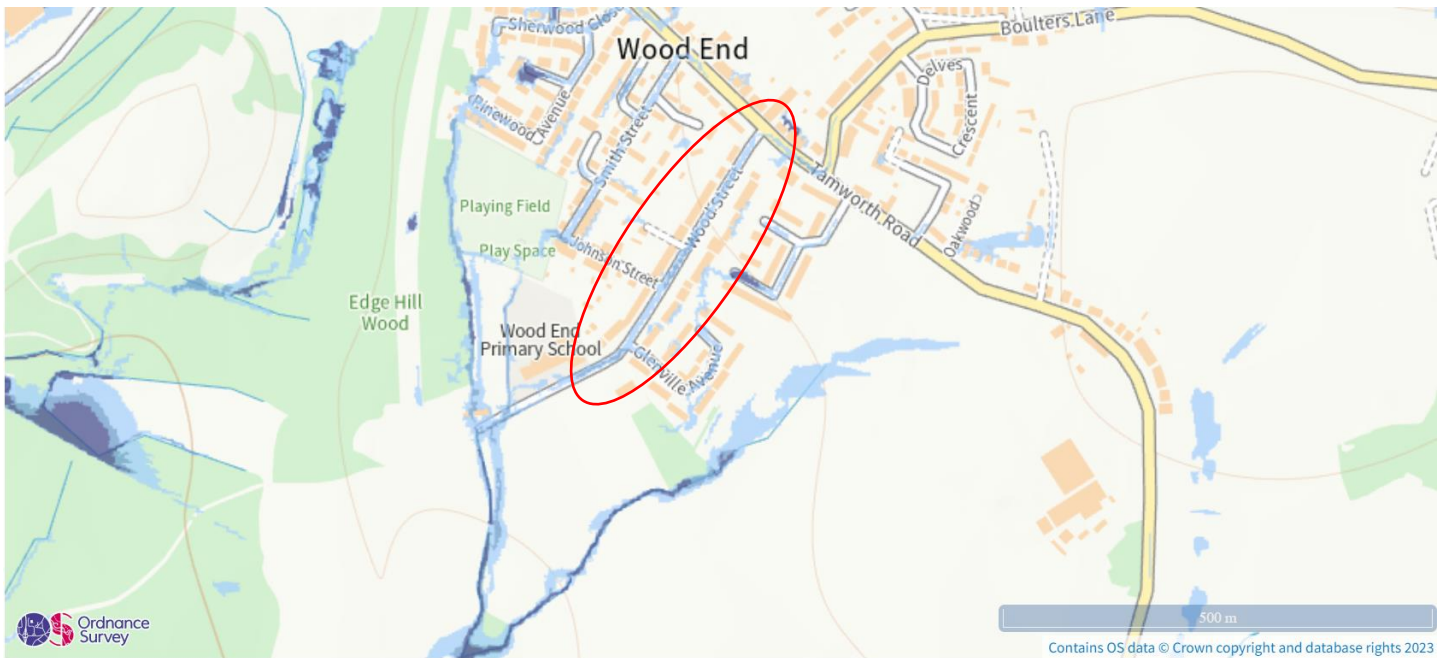
*Figure 4, Source EA*

Surface water flows originating in the high land on Tamworth Road flowed down Wood Street overwhelming the WCC County Highways and Severn Trent Water (STW) systems. Tamworth Road sits with a highway finished level of 122.0 m with the lowest point of Wood Street sitting at 111.2m. After discussions with residents and partner organisations it has been determined that as a result of the intense rainfall event, artificial drainage networks becoming overwhelmed, flows began to back up out of manholes and gullies onto Wood Street. As many of the properties at this location have thresholds comparable to Wood Street, the resulting flows led to the internal flooding of five properties.

Watercourses to the West of Wood End Primary School were also found to be overgrown and the potential of a blocked culvert running underneath private land/Highway also resulted in one further property being internally flooded.

Figure 4 shows the EA surface water extent mapping for Wood Street. This does not accurately represent the flow routes reported during the event of 11<sup>th</sup> June 2023.

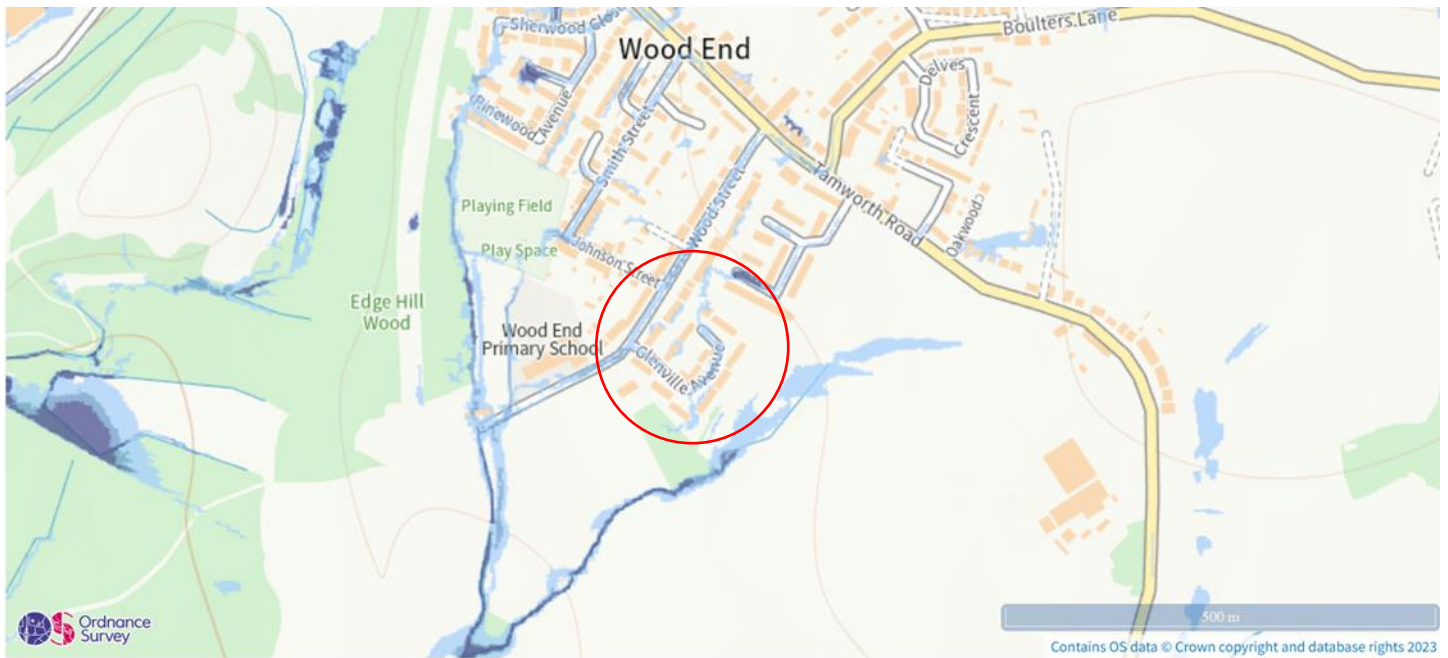
Figure 5, Source EA

Surface water flows originating in the high land on Tamworth Road flowed down Wood Street and then onto Glenville Avenue overwhelming the WCC County Highways and STW systems. As a result of the intense rainfall event, artificial drainage networks becoming overwhelmed and capacity exceeded, flows began to back up out of manholes and gullies onto Glenville Avenue. As many of the properties at this location have thresholds comparable to Glenville Avenue, the resulting flows led to the internal flooding of five properties.

Figure 5 shows the EA surface water extent mapping for Glenville Avenue. This does not accurately represent the exceedance flow routes reported during the event of 11<sup>th</sup> June 2023.

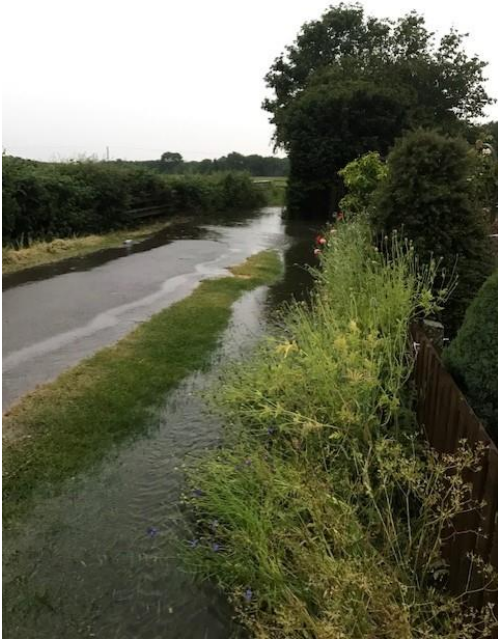
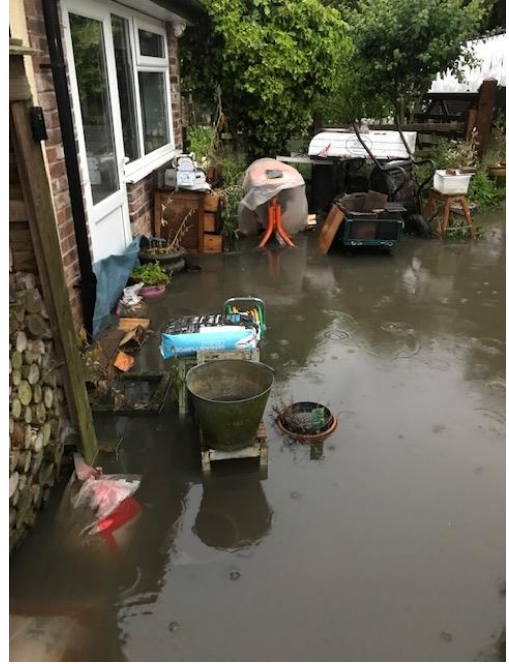
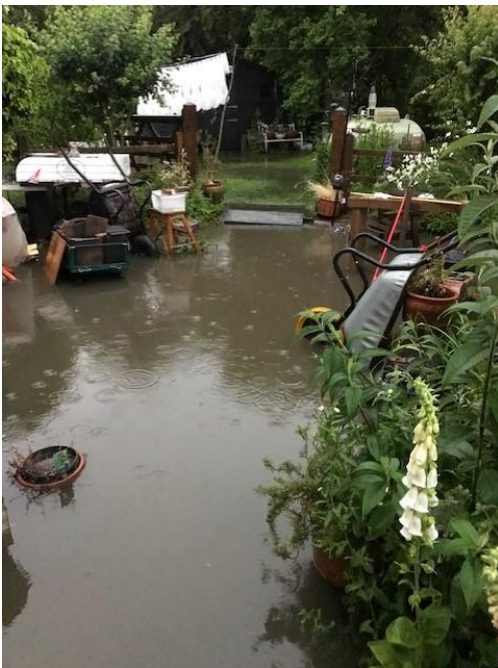
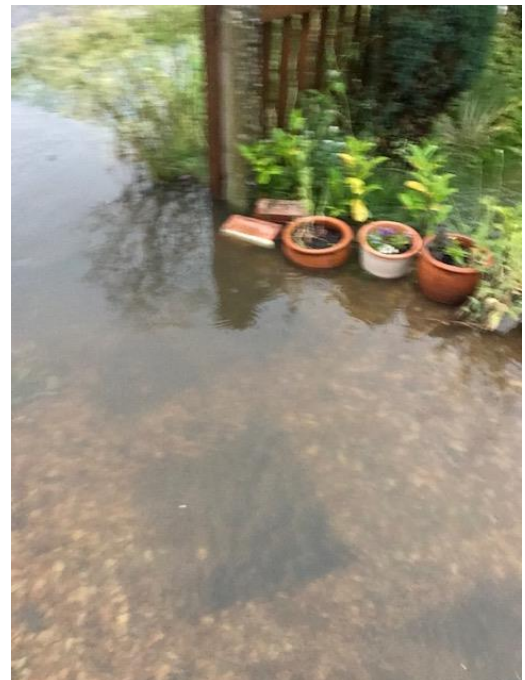
## 9 APPENDIX E – PHOTOGRAPHS

Numerous flood alerts were put into force however no fluvial response was reported during this event that impacted properties and flooding observed resulted instead from surface water flows and the inundation of artificial drainage networks, such as sewers. Where surface water flows were present, many of the resulting flow routes have exploited the built environment, such as highway, with the resulting effect of channelling water and inhibiting infiltration and was evidenced by the large amounts of surface water ponding on the highway. Flooding was reported in two main areas within Wood End, which are detailed below: Photos have been included in Appendix E.
