## Section 19 Flood Investigation

Lighthorne Flooding

March 2025

Warwickshire County Council as Lead Local Flood Authority

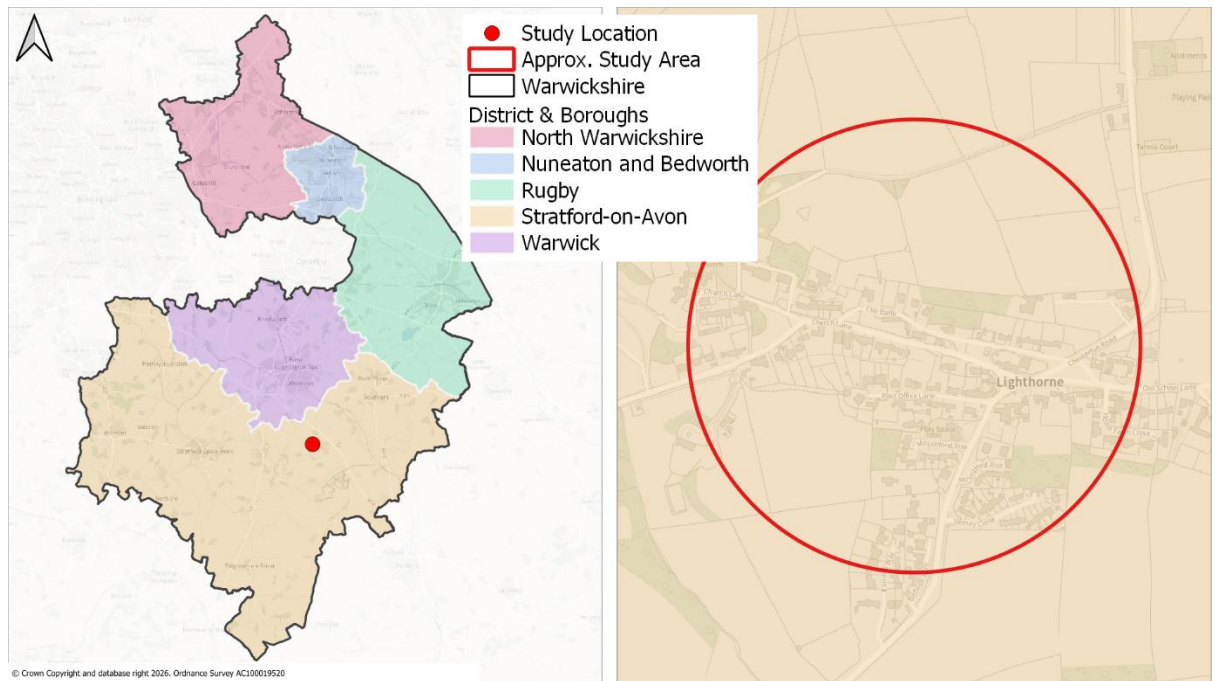
Figure 1 - Location of Lighthorne

- 2.1.1 The village of Lighthorne is located to the south of Warwick in the south of Warwickshire within the Stratford District. Figure 1 shows the area impacted by flooding which is covered in this report, with the LLFA receiving reports of flooding on Church Lane and The Bank .

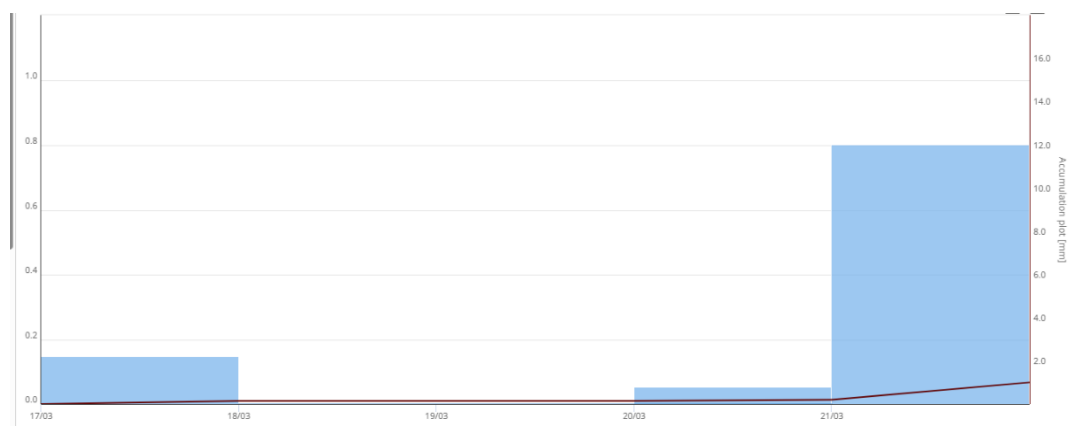
Figure 6 - Rainfall Leading up to the Event

- 5.1.1 In the weeks leading up to the flood event, weather conditions had been relatively dry. Hydromaster, a software which WCC utilises which provides real time and historic rainfall data from the Met Office, shows the rainfall amount over the preceeding five days between 17th March 2025 to 22nd March 2025. The total accumulation over the five days was 1mm, as shown in Figure 6.

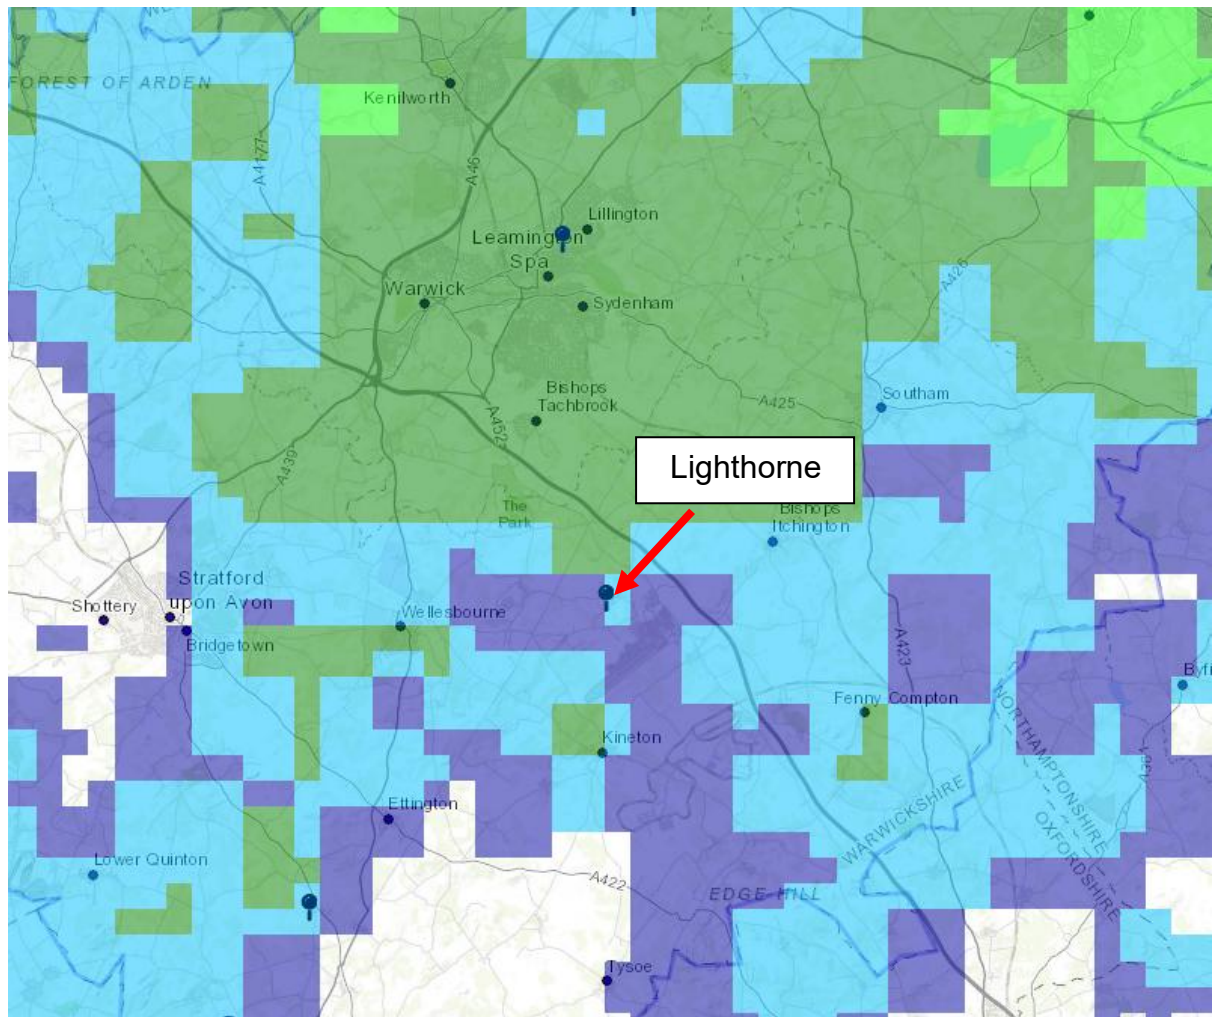
Figure 7 - Rainfall Radar Data During the Event

- 5.2.1 Rainfall radar data for Lighthorne obtained through Hydromaster shows the rainfall across south Warwickshire on 22nd March 2025. It can be seen that rainfall was widespread across south Warwickshire (as shown in Fig. 7). The rain began around 19:00 on 22nd March 2025, looking to be at its worst in Lighthorne at around 20:00, and then slowing down around 21:00.

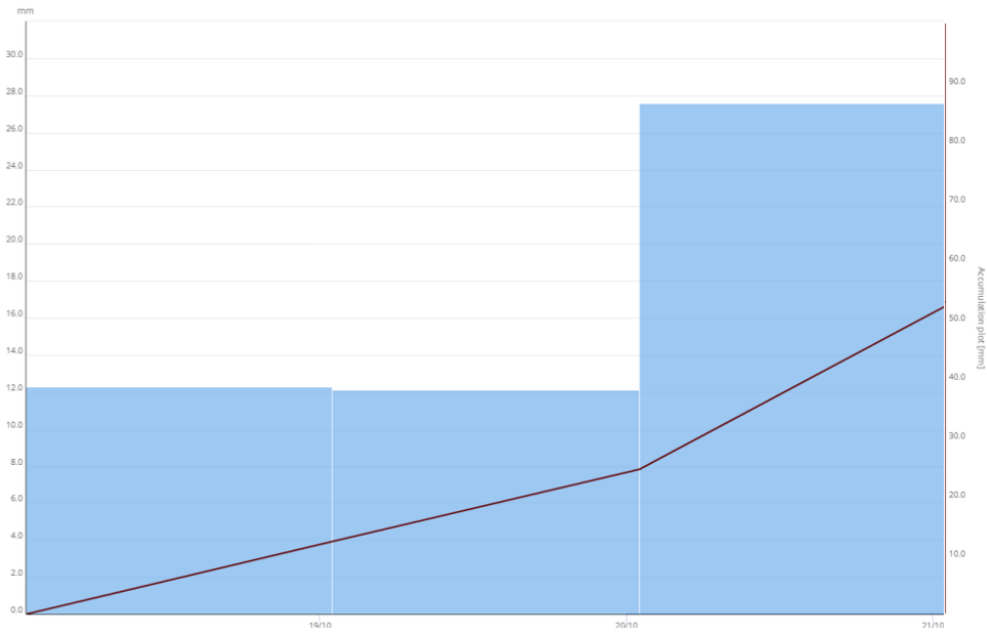
Figure 8 - Rainfall During the Event

- 5.2.2 By using the Hydromaster rainfall data the event itself can be analysed. Centred on Lighthorne, Hydromaster data shows 27mm of rain falling on the day of the event. When considering the preceding three days outlined in 5.1.1, the total accumulation over the three days including the day of the storm was 52mm, as shown in Fig. 8.

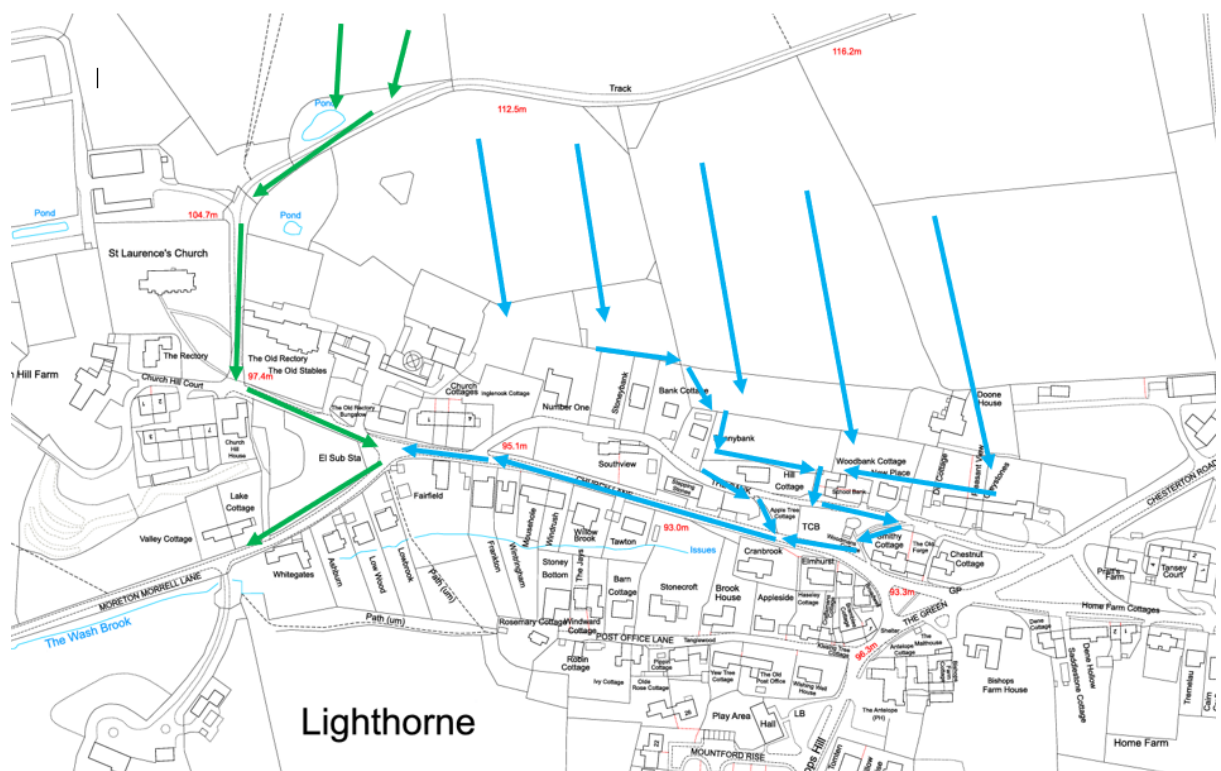
Figure 9 - Lighthorne Flooding - Source and Pathways.

- 6.2.2 From the investigation undertaken, it is understood that the flooding originated as overland flows from the fields north of Lighthorne. These are large open fields situated to the north of the Village with little developed or positively drained areas. This land is largely devoid of any features such as drainage ditches or watercourses that could act as interceptors of sheet flows. The sheet flows appear to have built during the heavy downpours experienced on the 22<sup>nd</sup> March 2025, which ran down the steep sided slopes on the northern side of the valley. Immediately north of the properties along "The Bank" there is a small copse of trees which does have a shallow ditch running along the western and southern boundary which appears to be a historical attempt to alleviate flooding to the properties on The Bank. This ditch is shallow and unmaintained and extends roughly to the eastern extent of the trees behind The Bank. The ditch flows south between two gardens and outfalls onto The Bank where it discharges onto the highway and ultimately into the highway drainage system via a small highway gully in the vicinity of the outlet.

- 6.2.3 The properties along the eastern end of The Bank were the worst affected by the flooding on the 22<sup>nd</sup> March 2025. From anecdotal evidence supplied by the residents at the drop in event, the water reached the properties on The Bank and largely drained onto the highway via surface flow routes running down private paths found along the sides of the houses. However, the properties at the east end of The Bank experienced water collecting against the walls of the properties, with the properties themselves appearing to have acted as a barrier to the overland flows resulting in water backing up against external walls and infiltrating through the walls and into the properties over the course of the storm event. This appears to be what led to the majority of the reported internal flooding to properties on The Bank.

- 6.2.4 The flooding to Lighthorne on the 22<sup>nd</sup> March 2025 was exacerbated due to the highway drainage system being overwhelmed by the sheer volume of rain that fell during the Storm event. Reports were received, with corroborating pictures and videos, showing large volumes of surface water flowing down the highways, particularly the eastern side of Church Lane which led to internal flooding of a number of properties on the road. This flood water continued toward the west of the village down Moreton Morrel Lane, flooding further properties and eventually discharged downstream into the Wash Brook west of the village.

- 6.2.5 The primary source of the flooding to the western end of Church Lane and Moreton Morrell Lane is also believed to be from surface water flow from the fields north of the village. There is a network of drainage ditches situated north-east of the church which appears to capture and convey some of the runoff from the fields. This ditch disappears at the top of the farm track adjacent to the Church, however, there appears to be nothing in place to convey water beneath this track to connect it to the drainage ditch which runs along the western edge of the track. Instead, it appears that water flows down the farm track and onto Church lane, into the village, bypassing the existing drainage systems altogether.

- 6.2.6 The flood water is understood to have flowed via two primary routes in the village. The first Route which resulted in the majority of the reported internal floods is from the fields behind The Bank and is indicated by the blue route indicated in Fig. 9. The Secondary route is indicated in green and flowed down the track adjacent to the Church and down Church Lane contributing to confirmed internal flooding of one property on Moreton Morrell Lane. It is worth noting however, that the green flow path appears to be a more regular exceedance route that leads to repeat highway flooding during periods of heavy rain.
