# B4114 Coleshill, Blythe Bridge

## Casualty Reduction Scheme Overview.

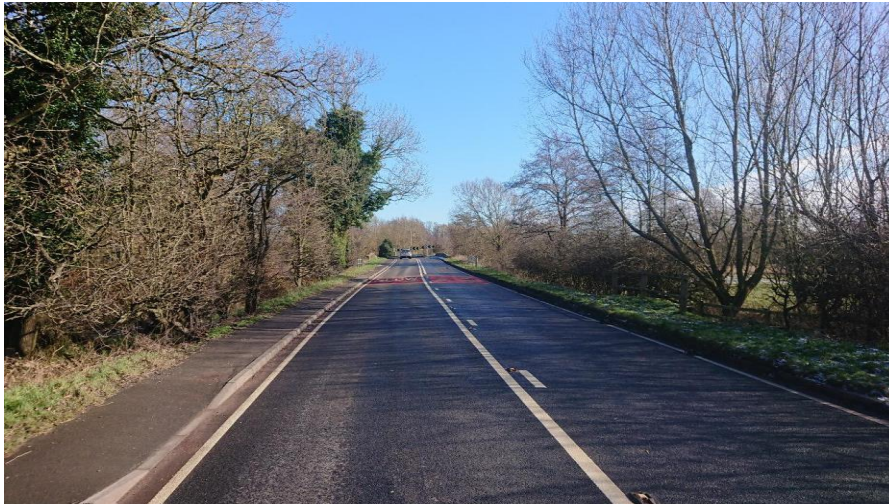
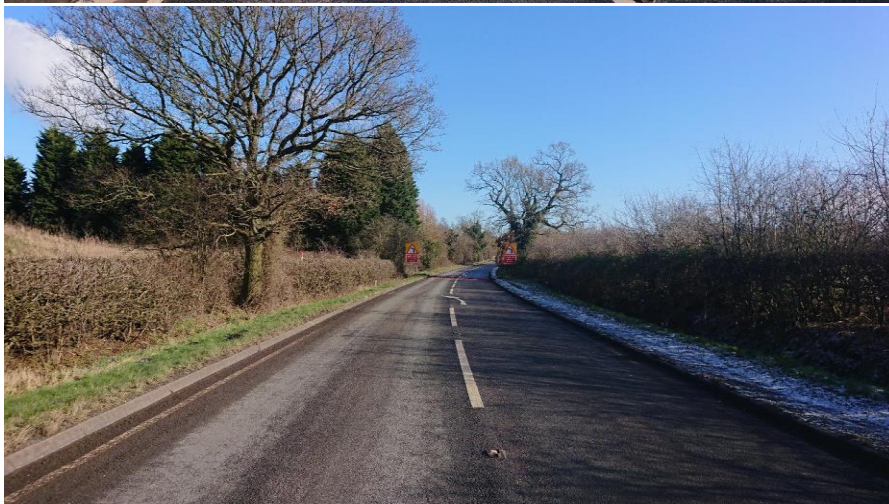
North-East bound approach

Before the improvement works had been carried out, there were only 2 x bend warning signs with Reduce Speed Now plates on yellow backing boards to give the motorists advance warning of the approaching sweeping left hand bend. Which were accompanied by SLOW markings on the carriageway along with a further SLOW carriageway markings closure to the bridge.

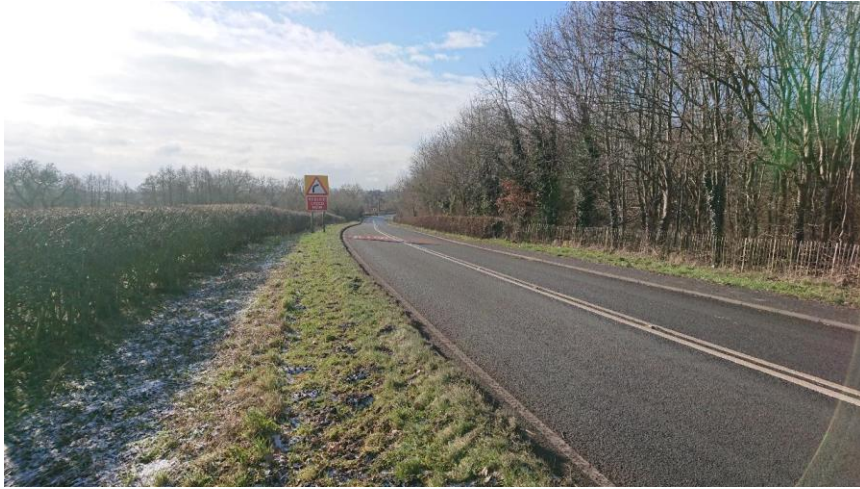
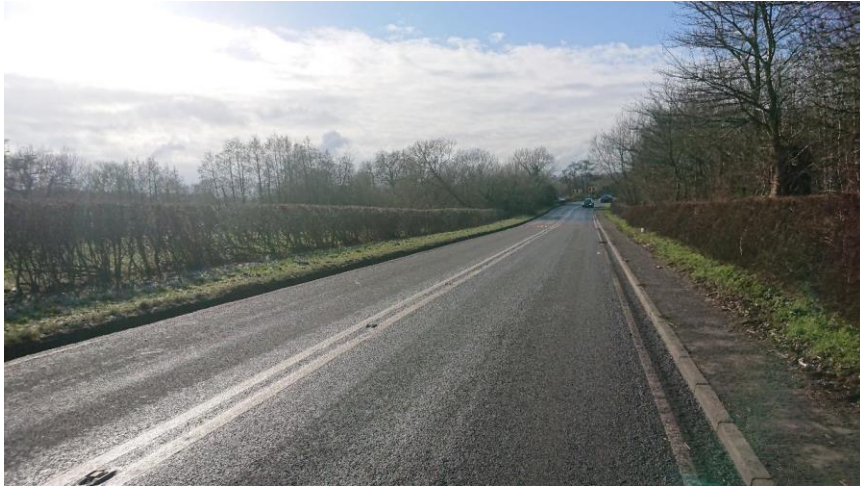
South-West bound approach

Before the improvement works had been carried out, there was only 1 x bend warning signs with reduce speed now plates on yellow backing boards to give the motorists advance warning of the approaching sweeping left hand bend. Which were accompanied by SLOW markings on the carriageway along with a further SLOW carriageway markings closure to the bridge.

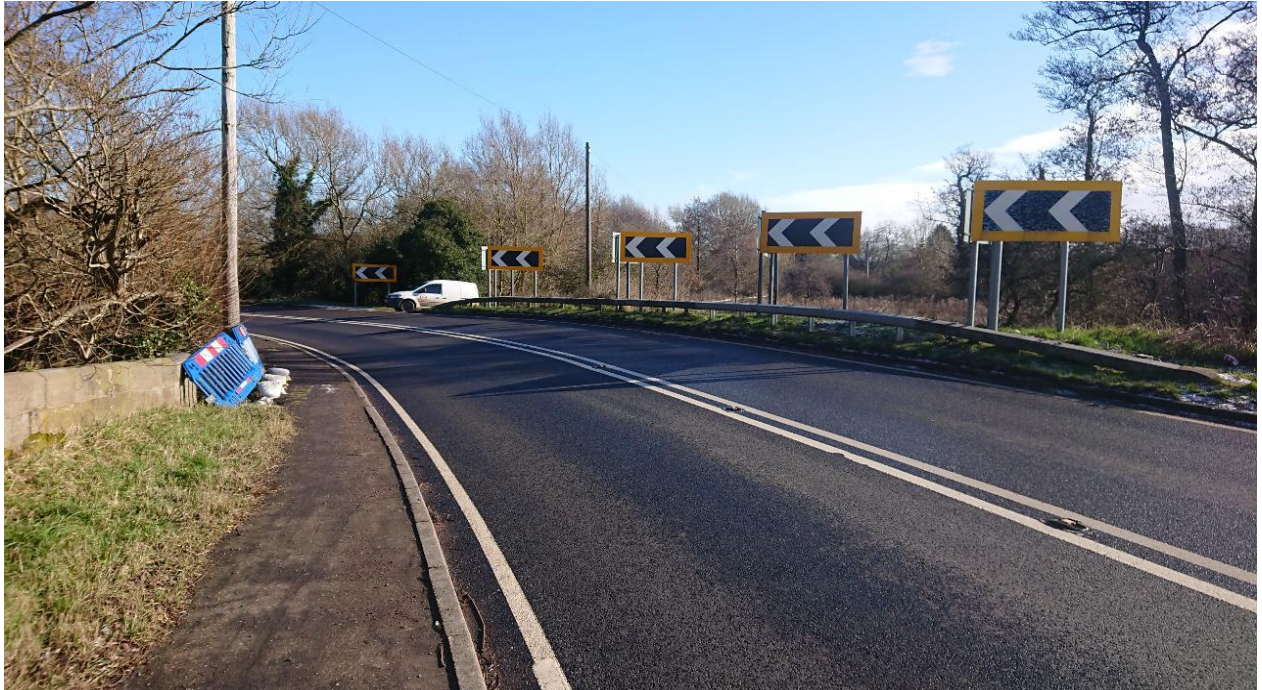
### **BEFORE IMAGE**

The improvement works on the bend included renewing of the worn and damaged chevron signs and updating the Vehicle Restraint System from the ramp ended style to the P4 terminals that work to absorb the vehicle and reduce the speed in a safe manner as these are designed with a crumple zone within the terminals.
