A428 Coventry Road/Lawford Heath Lane, Long Lawford

Casualty Reduction Scheme Overview

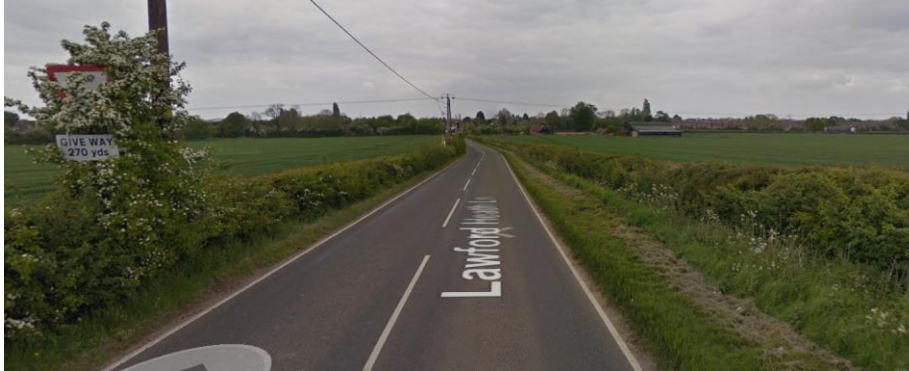
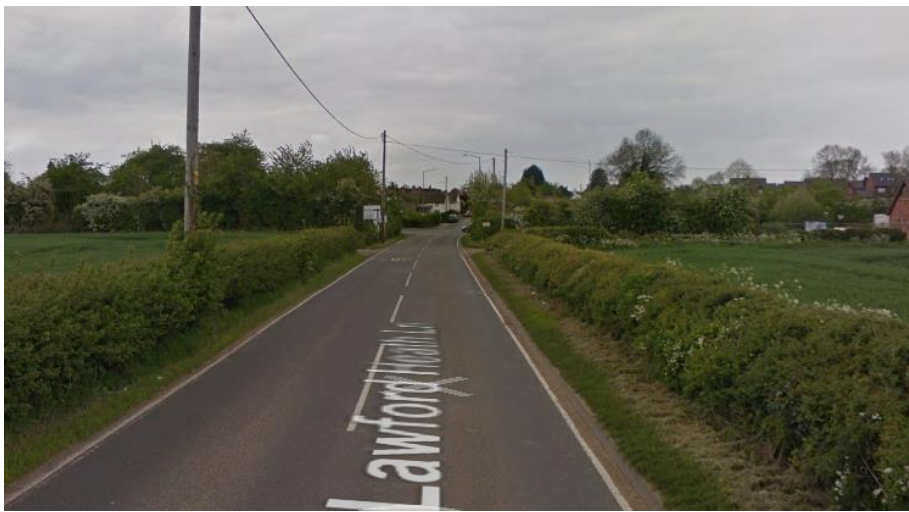
Lawford Heath Lane Northbound approach

Before the improvement works had been carried out, there was only one Give Way warning signs on the approach to the junction, the Advanced Directional Sign (ADS) only provided the height restriction for turning left, and SLOW road markings were worn.

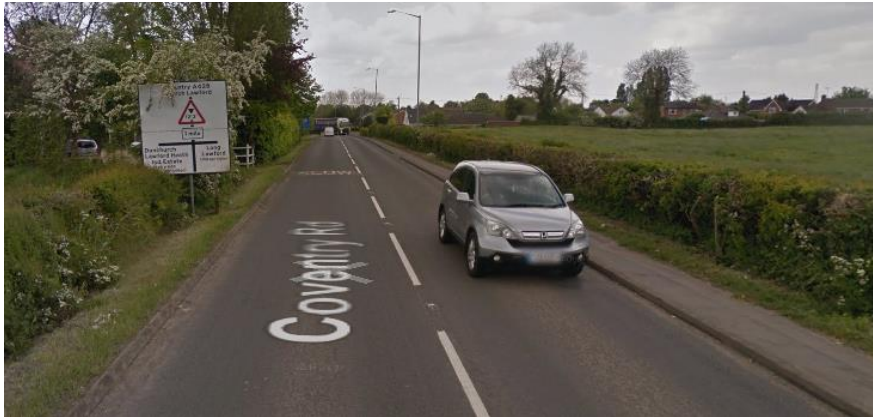
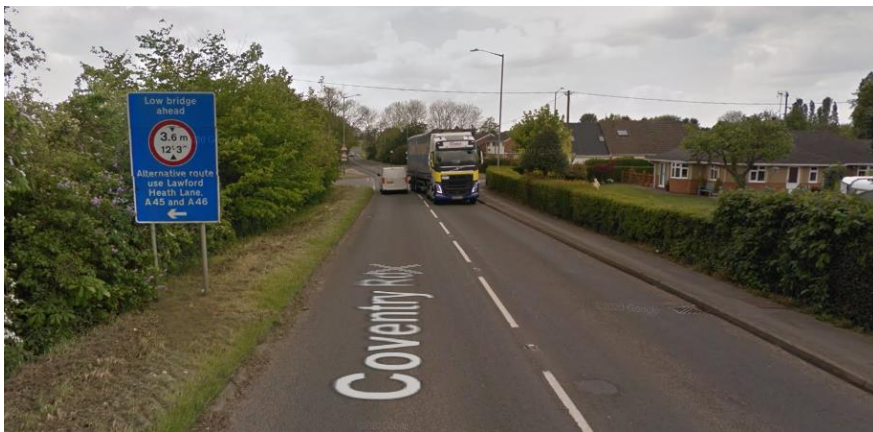
A428 Coventry Road Westbound approach

Before the improvement works had been carried out the ADS was in need of replacement, and the “Low bridge” sign needed to be updated to a warning sign as opposed to a regulatory. These were accompanied by SLOW markings on the carriageway.

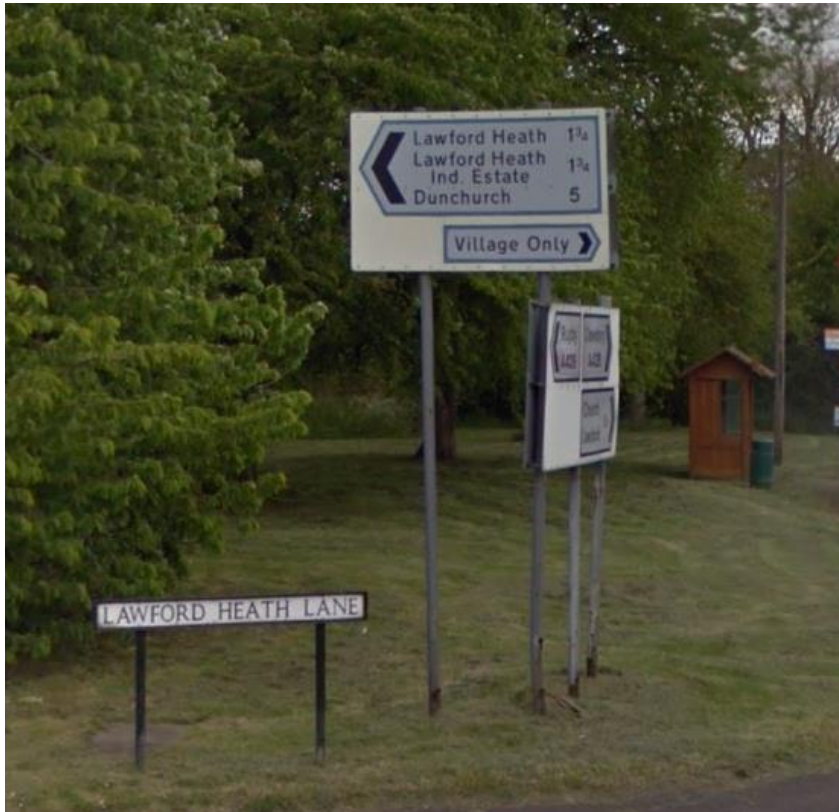
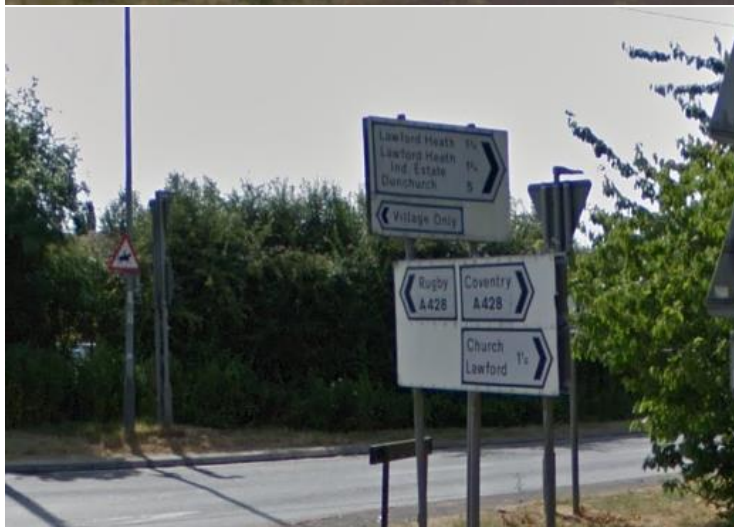
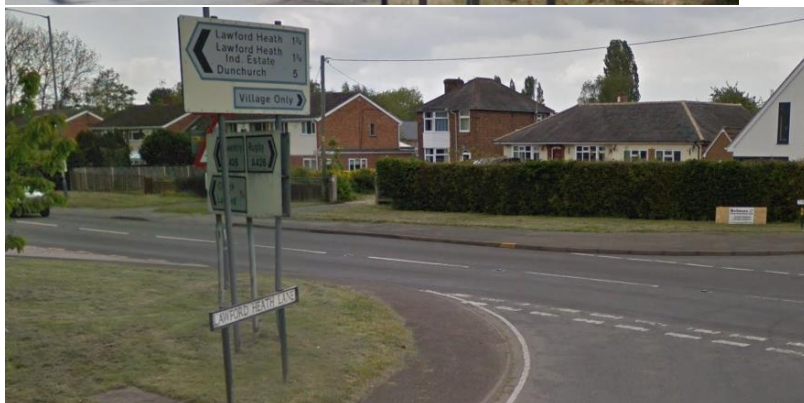
A428 Coventry Road/The Green/Lawford Heath Lane junction

Before the improvement works had been carried out the directional signs were in need of renewing, and relocation to be more visible.

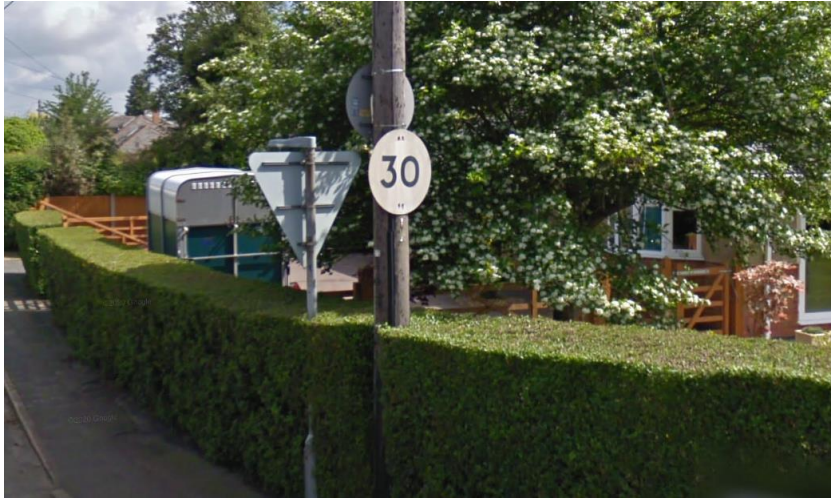
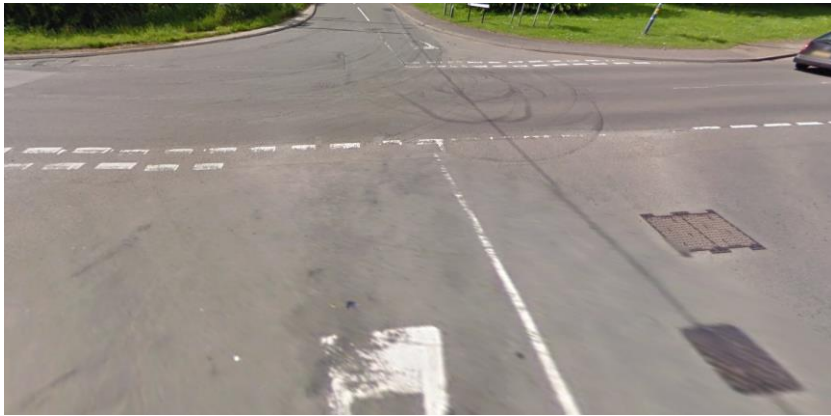
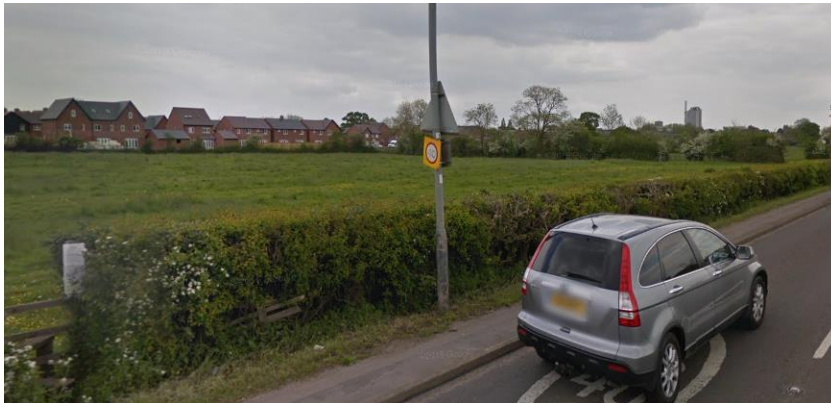
A428 Coventry Road and The Green

Before the improvement works had been carried out the speed limit signs were in need of replacement, the speed limit sign on The Green need to be installed on supports separate from the telephone pole, and the junction lines on The Green were in need of remarking.
