# A428 Lawford Road, Rugby

## Casualty Reduction Scheme Overview

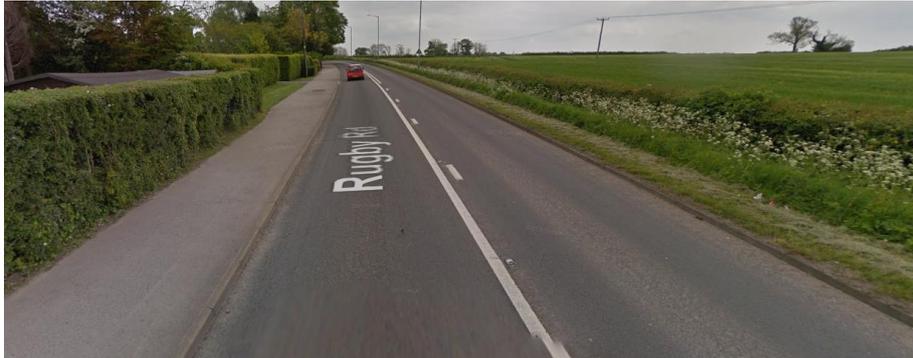
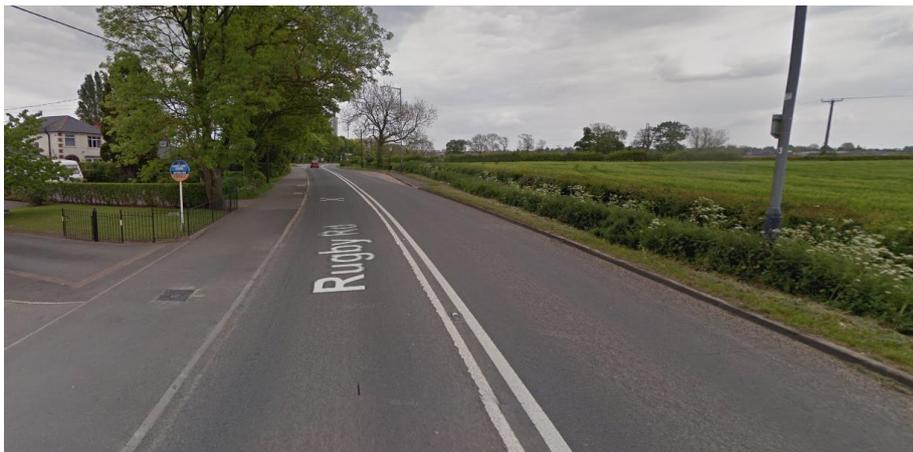
Eastbound approach

Before the improvement works had been carried out, there were no junction warning signs on the eastern approach to the junction.

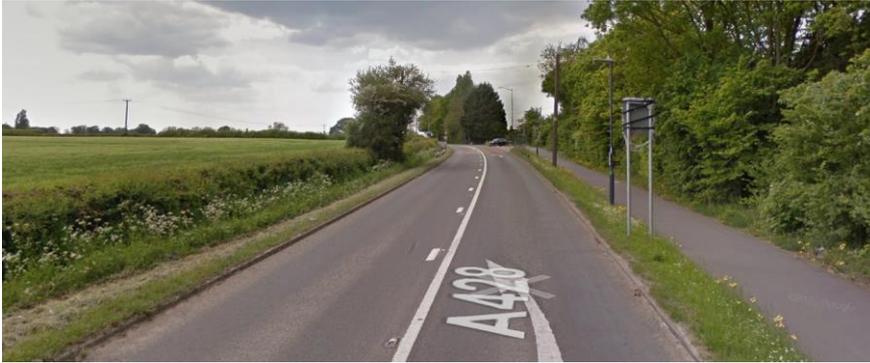
Westbound approach.

Before the improvement works had been carried out, there were no junction warning signs on the westbound approach to the junction.

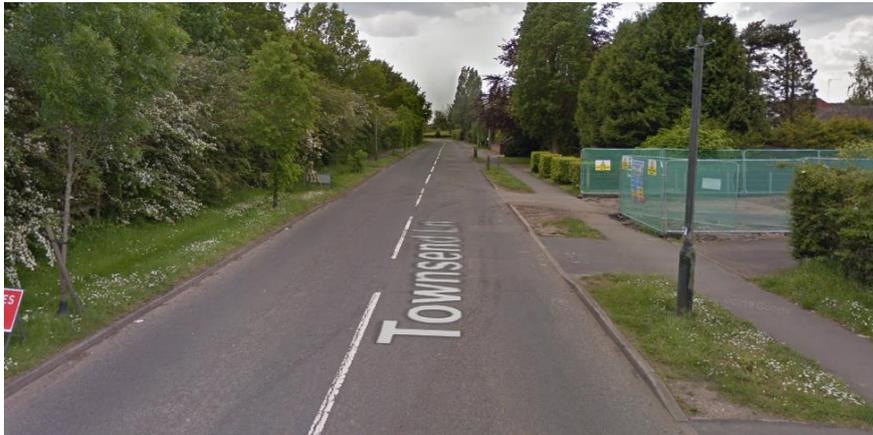
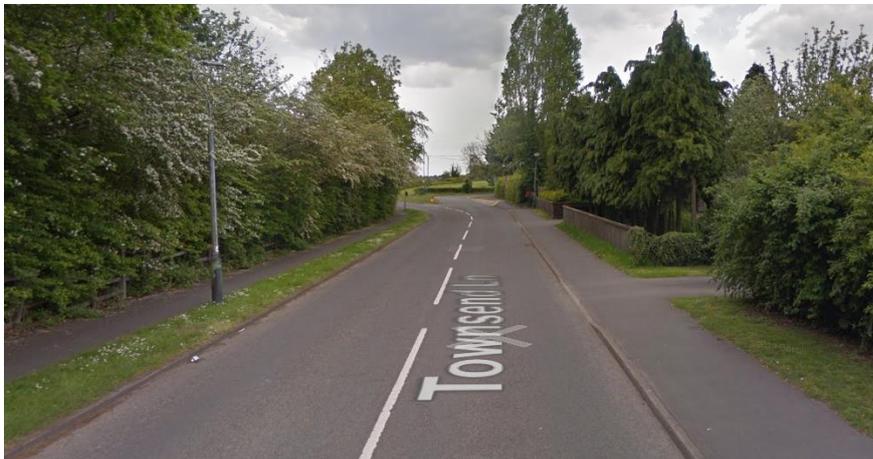
Townsend southbound approach.

Before the improvement works had been carried out, there were no junction warning signs on the eastern approach to the junction.
