### Eastern embankment approach to Bermuda Bridge

### Construction works on the Bermuda Bridge edge beam

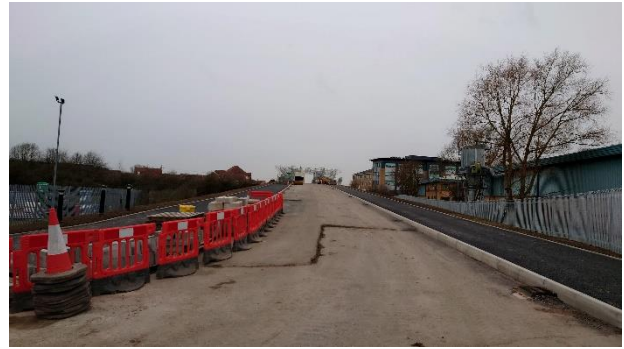
Works to the eastern embankment approach to Bermuda Bridge require the ongoing works on the Bridge to be completed and for construction plant to stop using this section of road to access the bridge before final surface course and road markings can be installed.

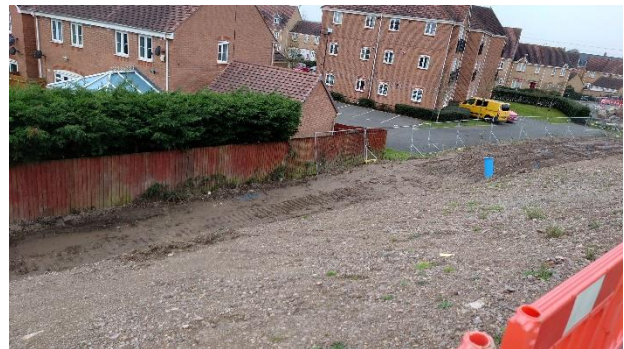
Area south of western embankment approach to Bermuda Bridge cleared in readiness to undertake works on the extension of the gas vent trench (GVT).

Once completed the excavation for GVT extension across The Bridleway can be backfilled to continue road construction.

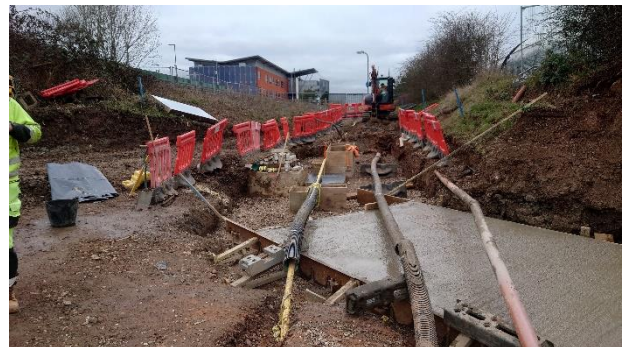
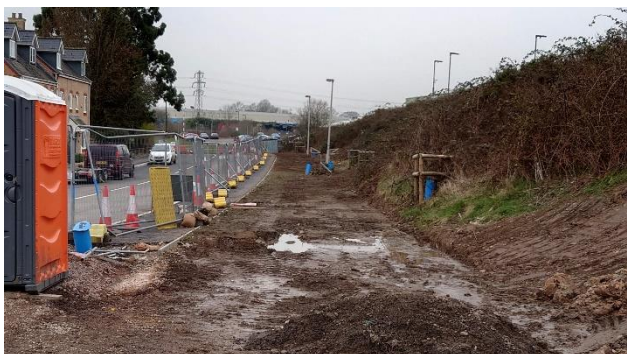
Work has commenced on protecting the existing utilities in Baring Way with 2.7 x 5m long reinforced concrete slabs and new large concrete manholes for the STW apparatus together with ducting for the gas and electrical supplies. Once the protection works is completed then the area can be backfilled in readiness for the GVT extension works.

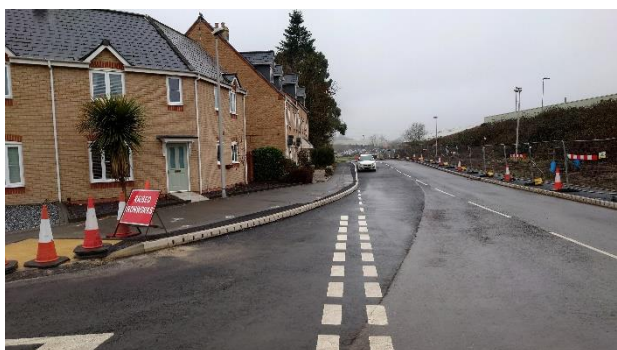
Northern Verge of The Bridleway opposite Templar Drive has been cleared in readiness to commence GVT extension works
