### Eastern embankment approach to Bermuda Bridge

### Construction works on the Bermuda Bridge northern edge beam

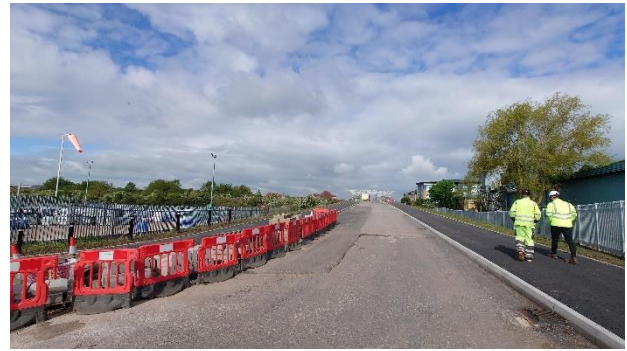
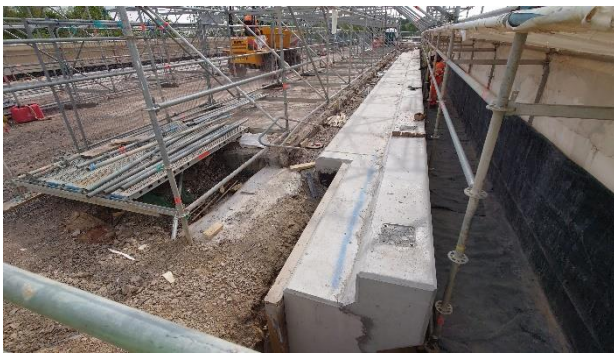
Once construction plant has stopped using this section of road to access the current works on the bridge, the final footway and road surface courses together with road markings will be installed to the eastern approach to Bermuda Bridge.

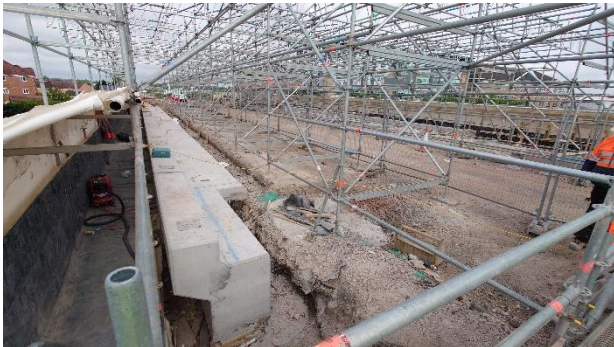
Northern Edge Beam and Parapet Upstands are completed. New safety parapet will be installed this week and the temporary scaffolding removed shortly. Following which new deck waterproofing, bridge joint material and new carriageway pavement will be installed.

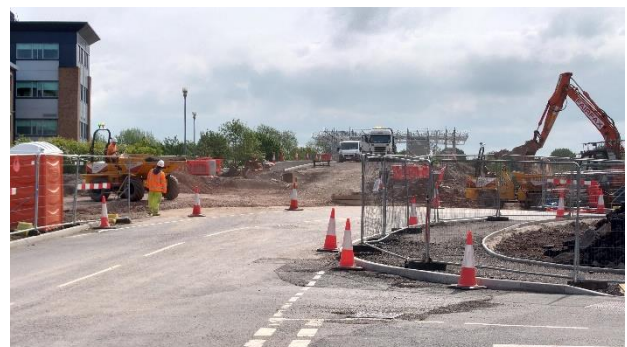
The western embankment approach to Bermuda Bridge is completed up to road base level and cleared in readiness for installation of surface course which will be installed following completion of works on Bermuda Bridge.

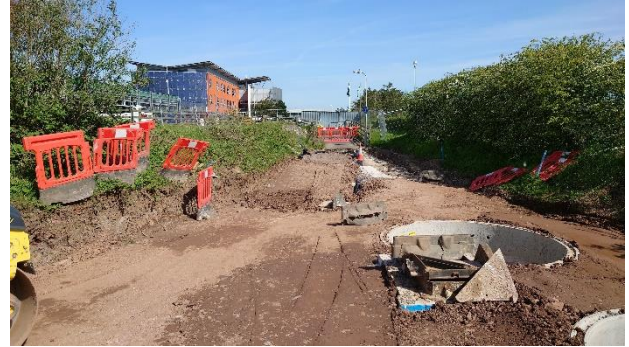
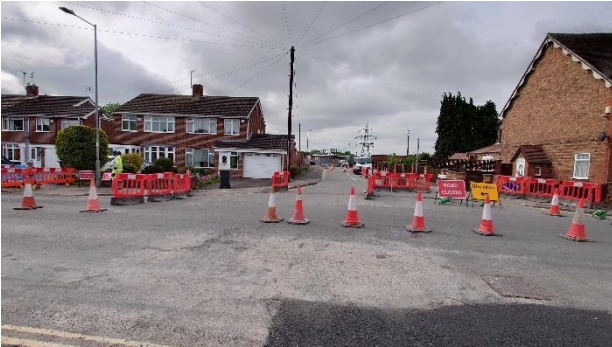
Barling Way and The Bridleway south of the western embankment approach to Bermuda Bridge is being backfilled up to road formation level and in readiness to undertake gas vent trench (GVT) extension works.

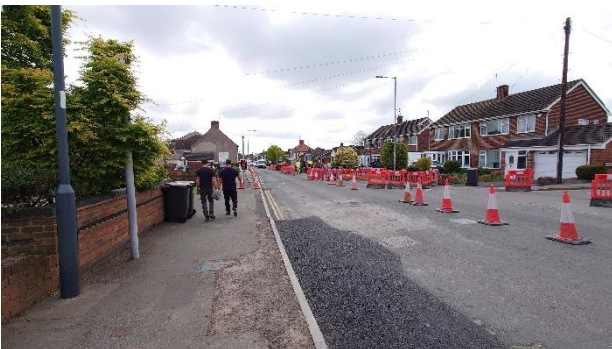
Traffic management on Heath End Road is in place to assist in safe passage of passing traffic through the works which are continuing as scheduled and planned to be completed in July 2023.
