# A452 Europa Way - Queensway to Princes Drive Signalisation scheme: Progress Update

## December

Date: 07/01/2025

Issue: No.7

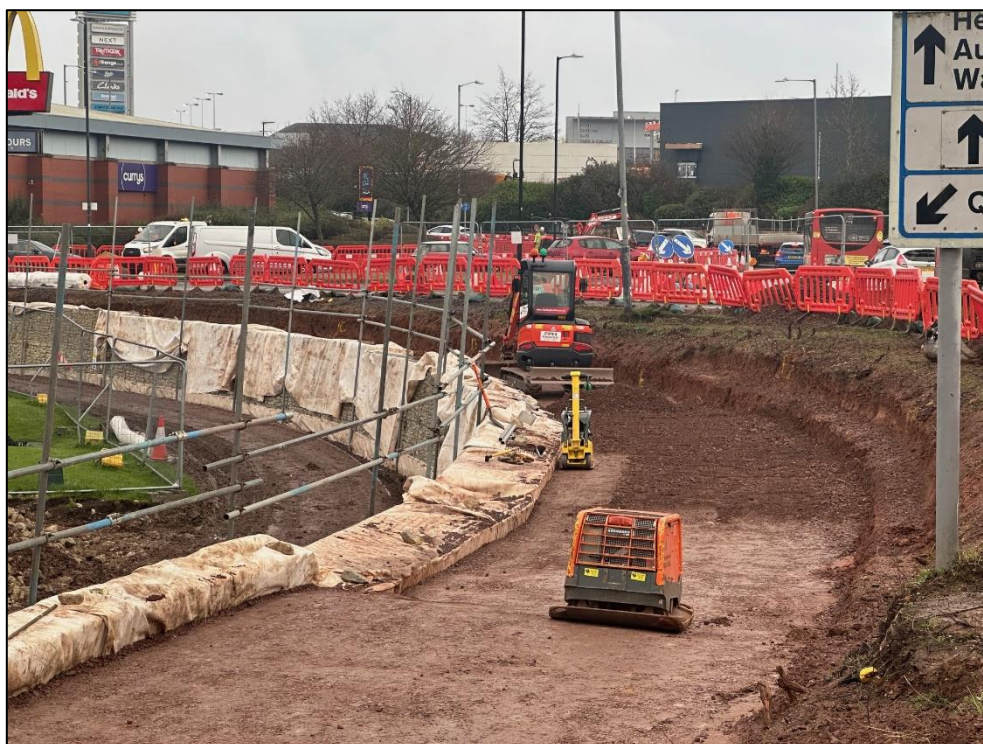
Principle contractor CR Reynolds then continued to carry out the major backfilling works to the rear of the baskets. Backfilling with structural fill is crucial for the stability and long-term durability of the retaining wall. The task must be carried precisely in line with stringent compaction standards using the correct compaction techniques to ensure the density of the backfill meets design requirements, see figure 1.

*Figure 1 Gabion Retaining Wall Backfill Works*

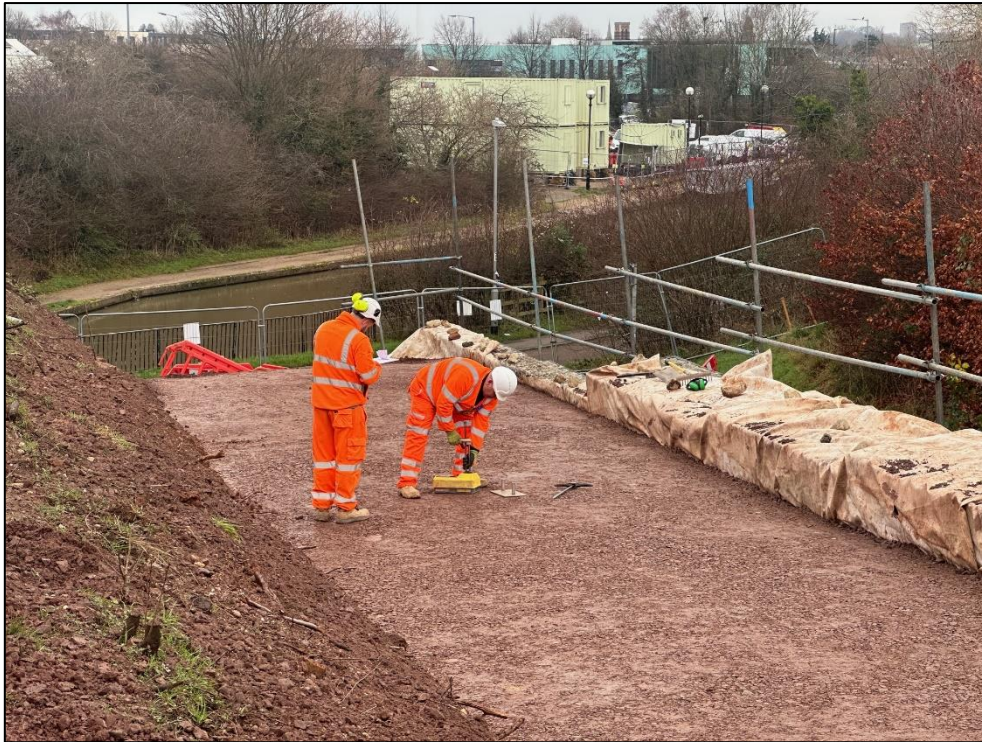
Throughout backfilling works, several density tests were periodically carried out by an external testing agency to ensure the compaction achieved was to the correct design requirements, see Figure 2.

*Figure 2 Gabion Retaining Wall Backfill Density Testing*

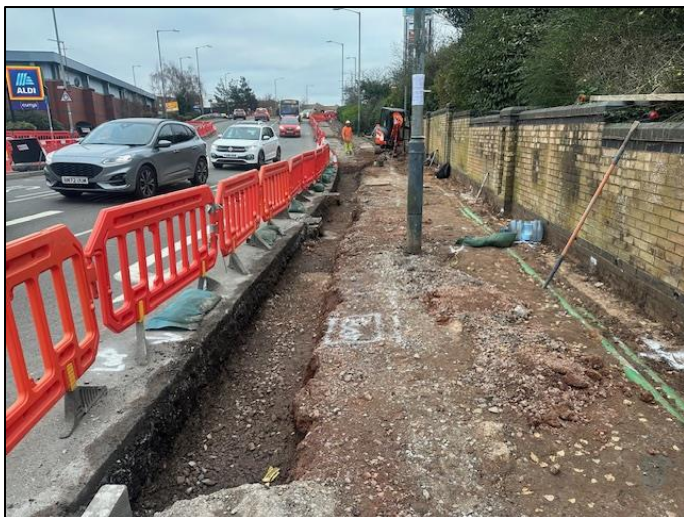
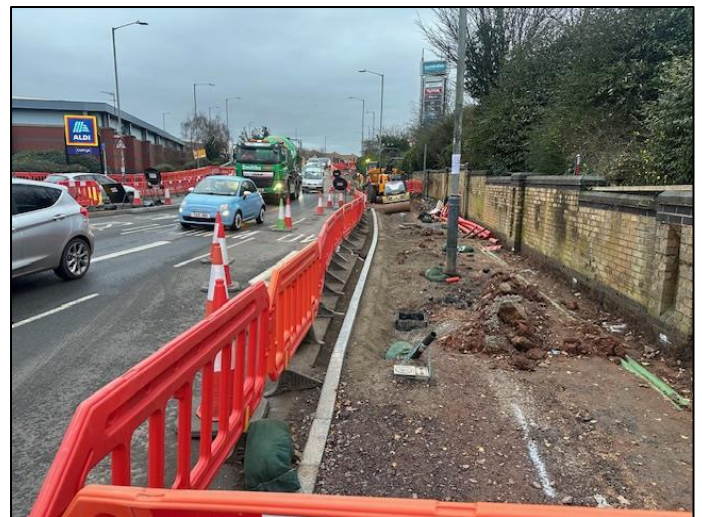
Phase D has continued as scheduled throughout December. All ducting for new the streetlighting columns and traffic signal ducting has been installed. The new kerb line and has also been laid, see figure 3.

*Figure 3 Phase D New Kerb-line Construction*

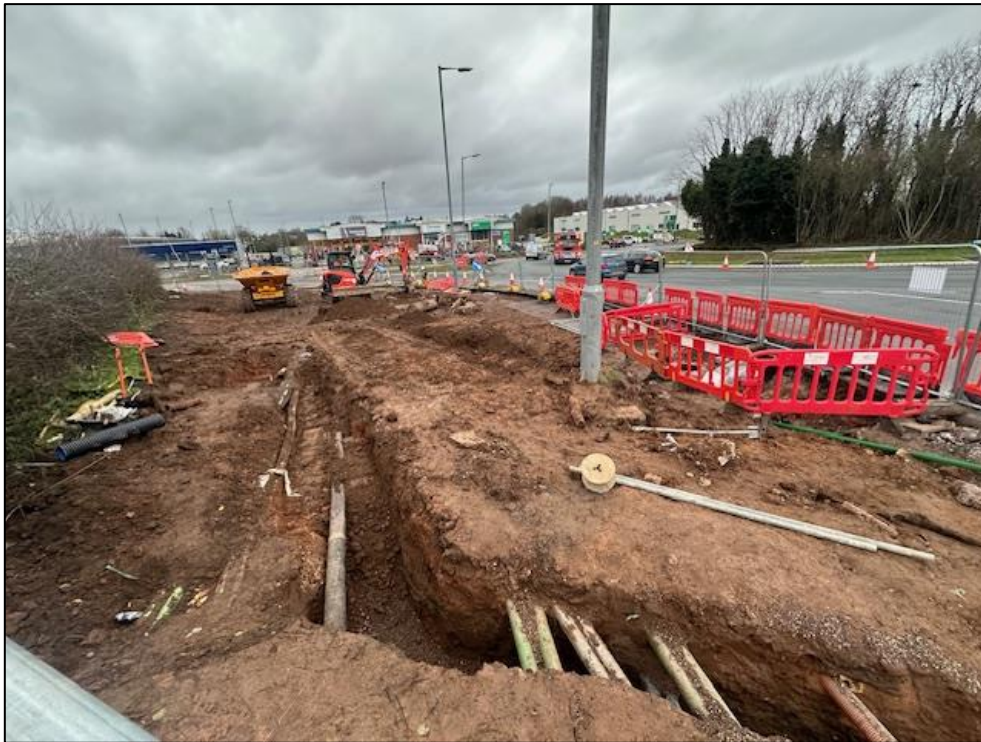
Phase H has continued throughout the month with further utilities diversions taking place to eliminate any clashes for the new widened carriageway construction. New carriageway drainage was also installed which will supply runoff flow to the proposed infiltration pond, see Figure 4.

*Figure 4 Phase H Drainage Duct Construction and Service Diversions*

The infiltration pond's purpose is to act as a natural vegetated filter to ensure carriageway runoff and pollutants are captured, the flow rate is slowed, and water is stored. This additional storage capacity will alleviate the stress on the existing highway drainage system further along the road network in storm events.

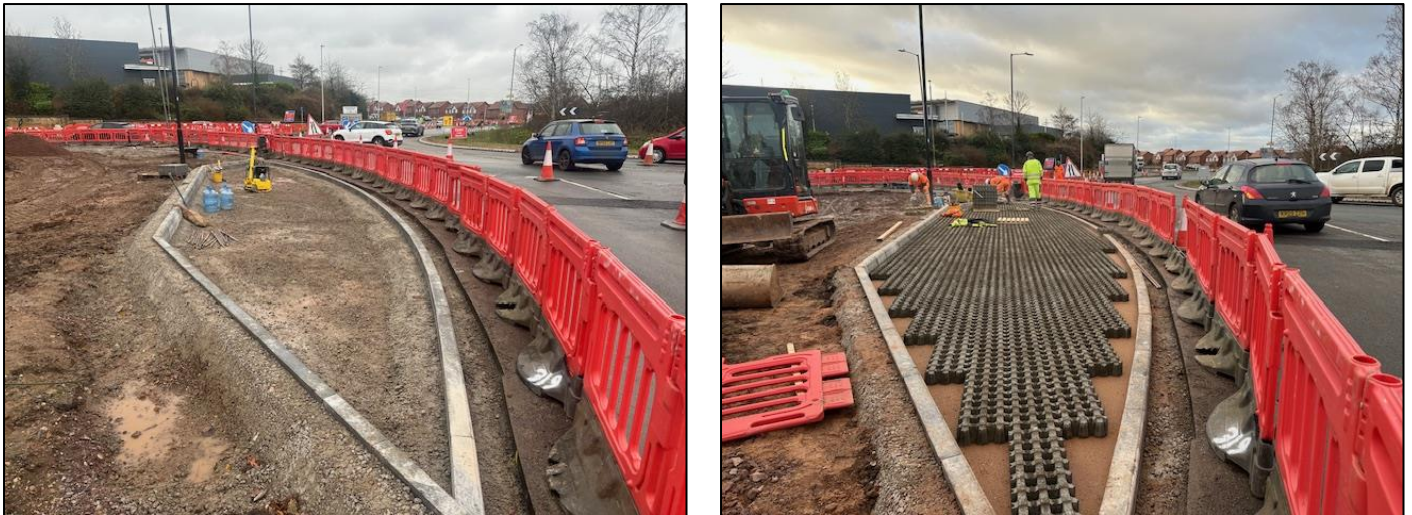
Throughout the month great progress was made. The existing kerb-line was removed and realigned. Earthworks began to facilitate a new traffic signal maintenance bay, which was subsequently paved in grass-crete allowing for a natural aesthetic once seeded over, see figure 5. Furthermore, a CCTV mast base was excavated and is awaiting casting in early January.

*Figure 5 Phase B Traffic Signal Maintenance Bay Construction*
