Section 19 Flood Investigation

Flooding 2020 Snitterfield, Stratford Upon Avon

Warwickshire County Council as Lead Local Flood Authority

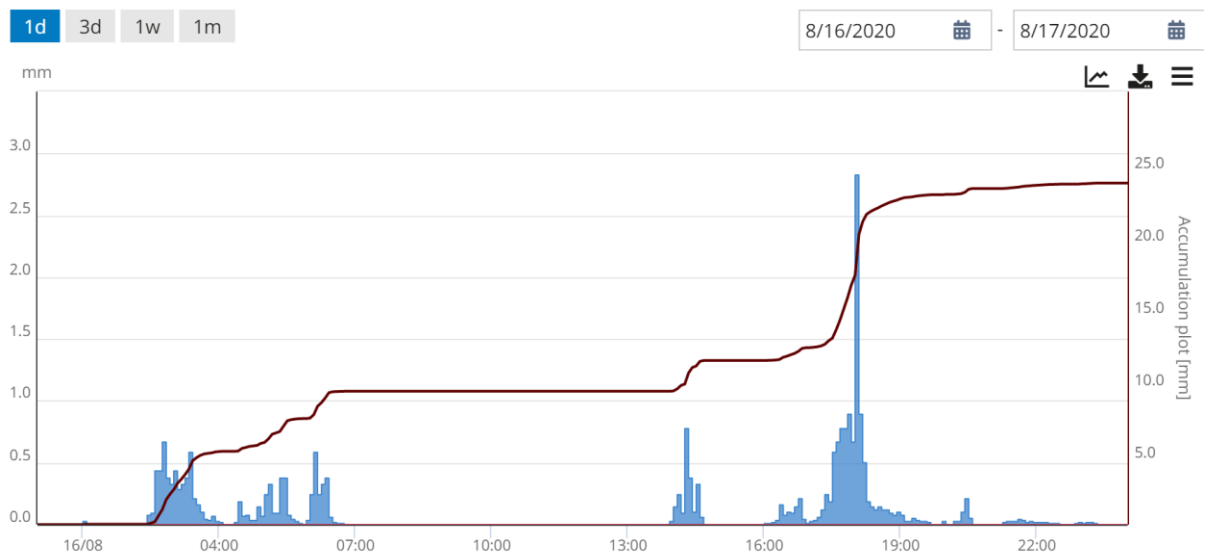
Figure 1, rainfall accumulations, source Hydromaster, data DTN

Rainfall radar data for Snitterfield obtained through Hydromaster, records that during the period of the 16 August 2020, that a daily rainfall total of 23.6mm fell. Peak rainfall rates were observed between 17:00 and 19:00hrs and correlate with the period of flooding reported.

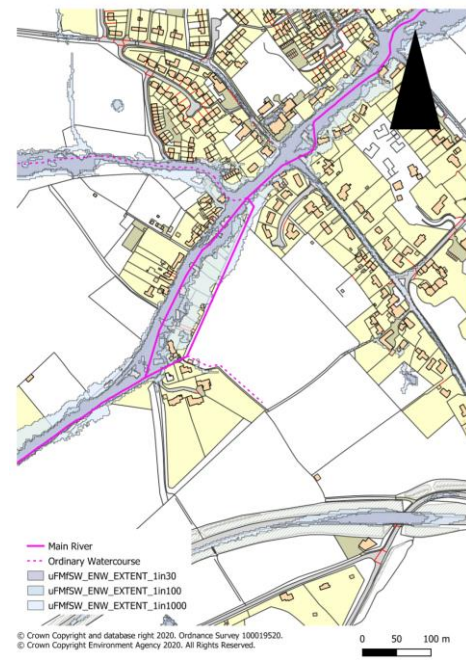
Source: Environment Agency (Risk of Flooding from Surface Water, main river mapping). Note this is modelled information indicative of the main risk areas. It does not indicate the areas that flooded in August 2020. Darker blues indicate higher risk.

Two distinct surface water flows were noted to have occurred during this event. The primary flow route created by flows coming out of bank from the ordinary watercourse and flowing down the area designated as a public right of way onto Duffins Piece. The Secondary flow route being overland flows generated within the higher agricultural land breaching the raised vehicle access and entering Duffins Piece through the gated access to the field. It is believed that overland flow routes formed not due to a result of a failure in the receiving infrastructure, but were a result of the intensity of rainfall and failures in the morphology of the channel.

An inspection of the ordinary watercourse identified that much of the original profile had been lost, with many self set trees and saplings now occupying the channel profile. It is likely that significant vegetation and tree removal would be required to undertake proactive maintenance.

No.	Action	Responsible party	Progress
1	Undertake appropriate channel maintenance	Landowner	Not yet instigated
2	Consider if desirable works can be undertaken to ordinary watercourse by LLFA. Works likely to include regrading of channel and reprofiling of surrounding land.	LLFA	Ongoing
3	Work with local flood group to explore options for maintenance and mitigation	WCC FRM	Ongoing
