## Section 19 Flood Investigation

Flooding in Warwick 12<sup>th</sup> August 2020

Warwickshire County Council as Lead Local Flood Authority

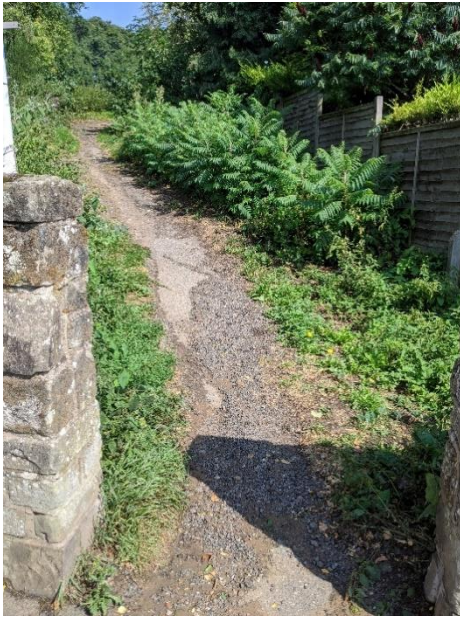
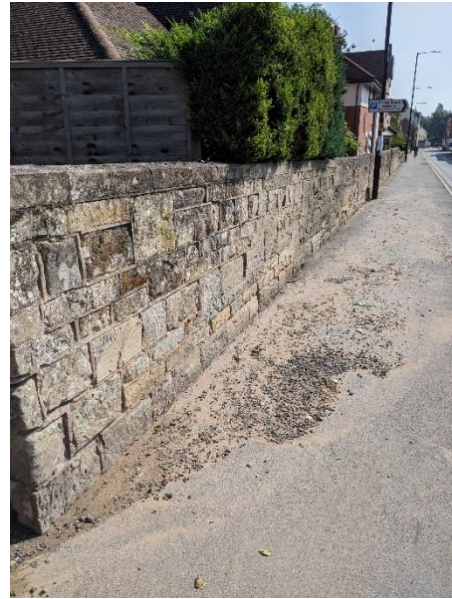
Flow paths could be seen to have cut into footpaths and washed silt out on to footpaths where overland flows had come from Priory Park, which is at a higher level than Priory Road. These are not picked up on the RoFSW mapping, however this was evidence to have also contributed silt to the highway and sewer systems, as shown in Figure 3.

Figure 3 – site photos taken the day after the flood event showing evidence of a flow path from Priory Park issuing on to the highway.

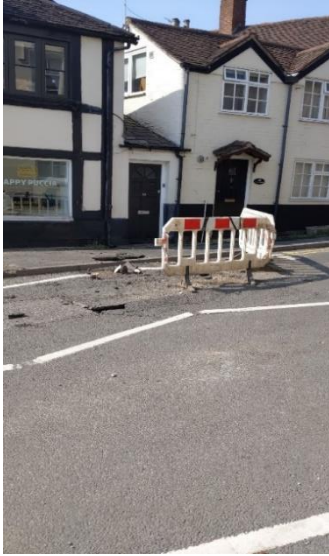
A surface water sewer was shown to have surcharged and suffered damage as a result of the intensity of rainfall. Previous work has been undertaken to upsize the surface water sewer system in Smith Street, which did not surcharge in this event. However, the system in Priory Road surcharged and damaged the manhole cover in Priory Road as shown in Figure 5 and Figure 6.

Figure 5 – Damage to highway and manhole cover sectioned off on site visit on 13<sup>th</sup> August.

Previous work has been undertaken on the Severn Trent Water sewer system in Smith Street, however further investigations should be undertaken into the system in Priory Road and likelihood of damage to the chamber shown in Photo 2 reoccurring. The LLFA have reported the issue to Severn Trent Water for further investigation.

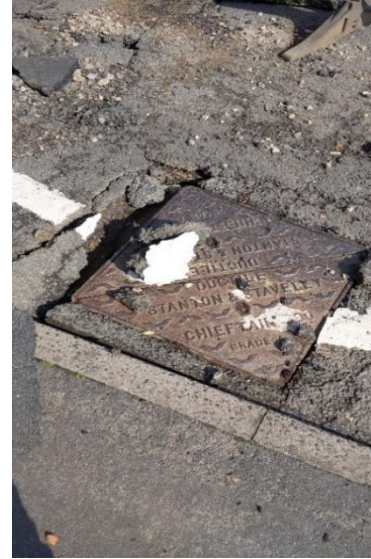
Figure 6 – Damage to surface water sewer manhole cover.
