Section 19 Flood Investigation

Flooding on Shuckburgh Grove, Leamington Spa

11 June 2023

Warwickshire County Council as Lead Local Flood Authority

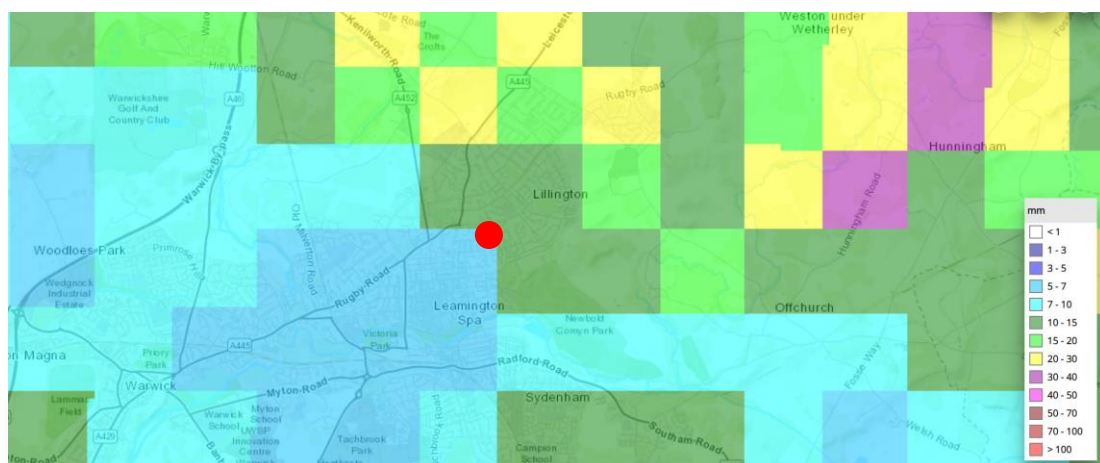
Figure 1 – Rainfall radar data from HydroMaster displaying the 3 hour moving accumulation total between 19:00 and 22:00 on 11th June 2023. The red point shows the location of Shuckburgh Grove.

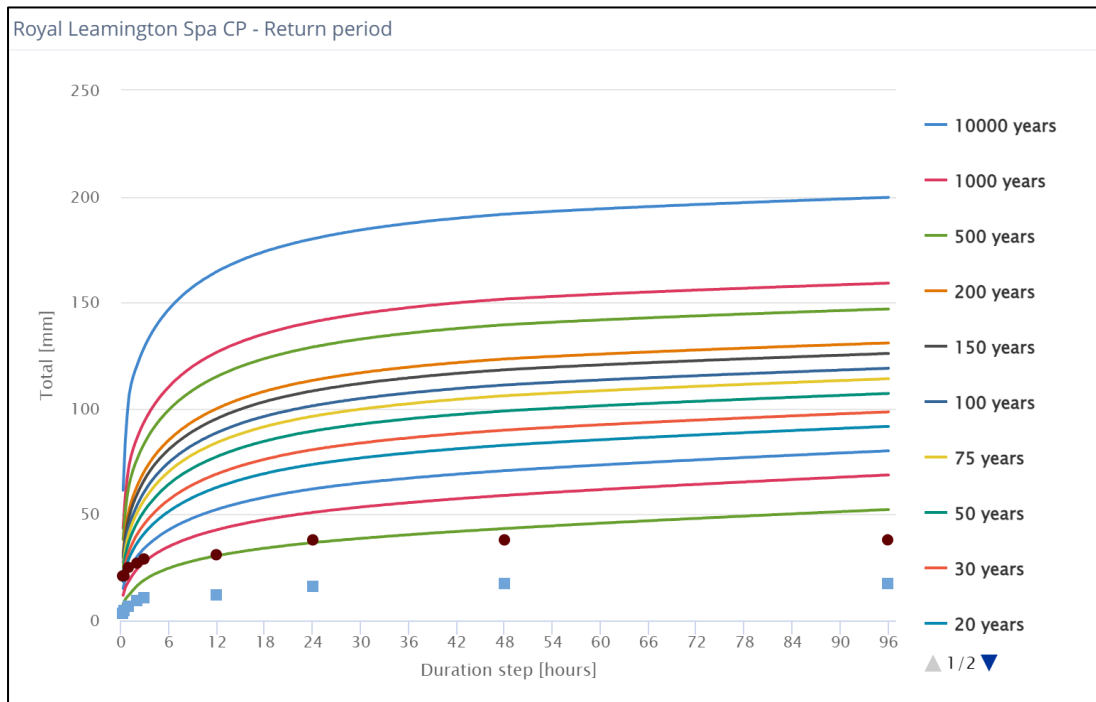
Figure 2 – Return Period mean and maximum values taken from HyrdoMaster for the Royal Leamington Spa catchment between 11th-12th June 2023.

When analysing the rainfall data over a wider catchment area, Royal Leamington Spa had a recorded intensity of 9.7mm/hr, with a total of 29mm of rainfall. This suggests a return period of between > 5 and <10 years this can be seen in Figure 2 above. Return periods are used to describe the probability of a flood event occurring, with larger numbers being associated with a lesser frequency.

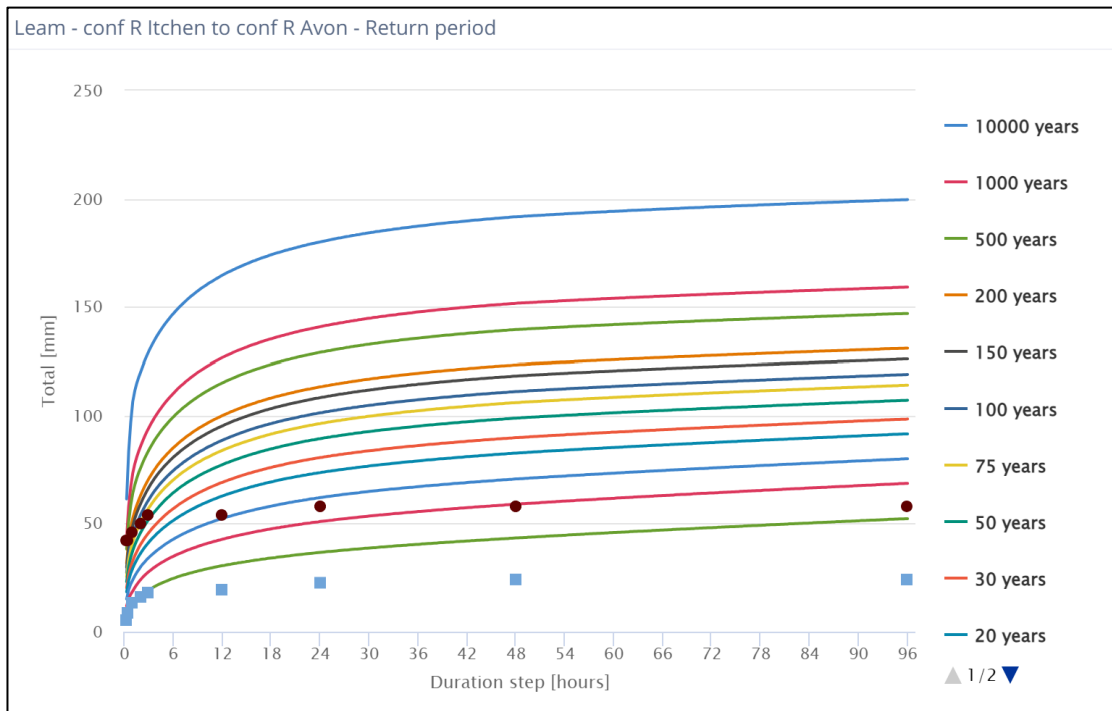
Figure 3 shows the return period mean and maximum values over the same period for the catchment of the River Itchen and the River Avon. The intensity was recorded at 18.0mm/hr, with a total of 54mm of rainfall being recorded, suggesting a rough return period for the event of between 50 and 75 years.

Figure 3 – Return Period mean and maximum values taken from HydroMaster for the River Itchen to the River Avon catchment between 11th-12th June 2023.

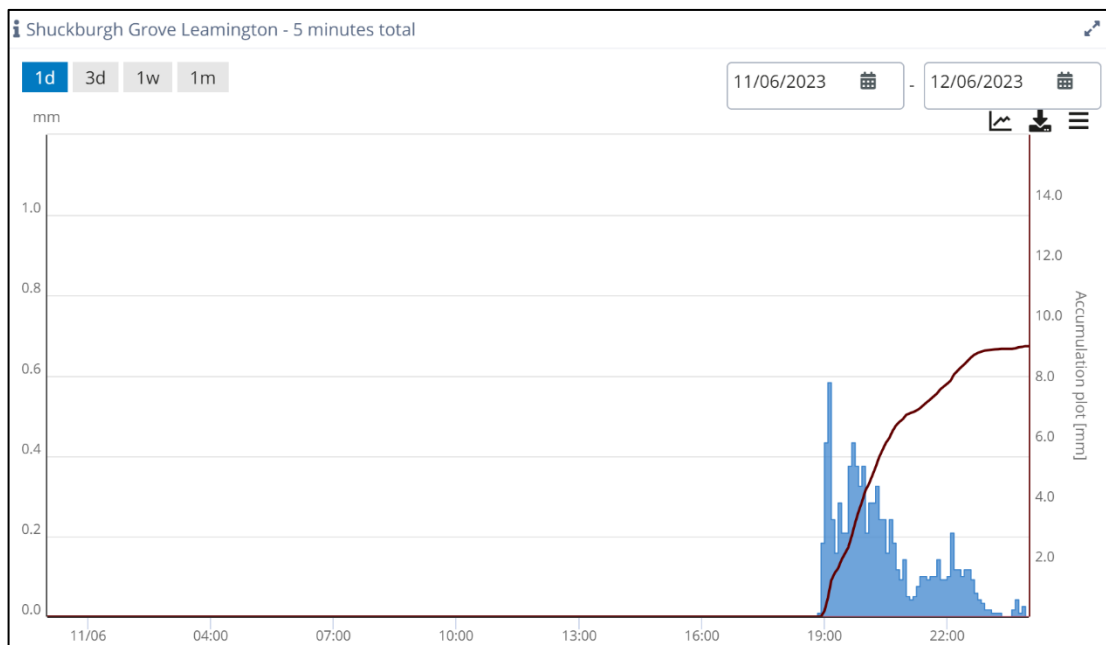
Figure 4 – Shuckburgh Grove rainfall accumulation sourced from Hydrometer over a 24 hour period, showing the rainfall peaking in the early evening of Sunday 11th June 2023.

HydroMaster allows rainfall data of both real time and historical can be analysed at a localised catchment level or analysed within more precise ‘hotspot’ locations. A hotspot was created for Shuckburgh Grove for the event however the rainfall and accumulation values were significantly lower than the surrounding catchment. This shows that the rainfall in the wider geographical area was more intense and will have resulted in water flowing through the catchment towards lower lying areas such as Shuckburgh Grove and potentially overwhelming the system downstream.
