Parkfield Rd & Main St Crossroads Rugby

Casualty Reduction Scheme Overview

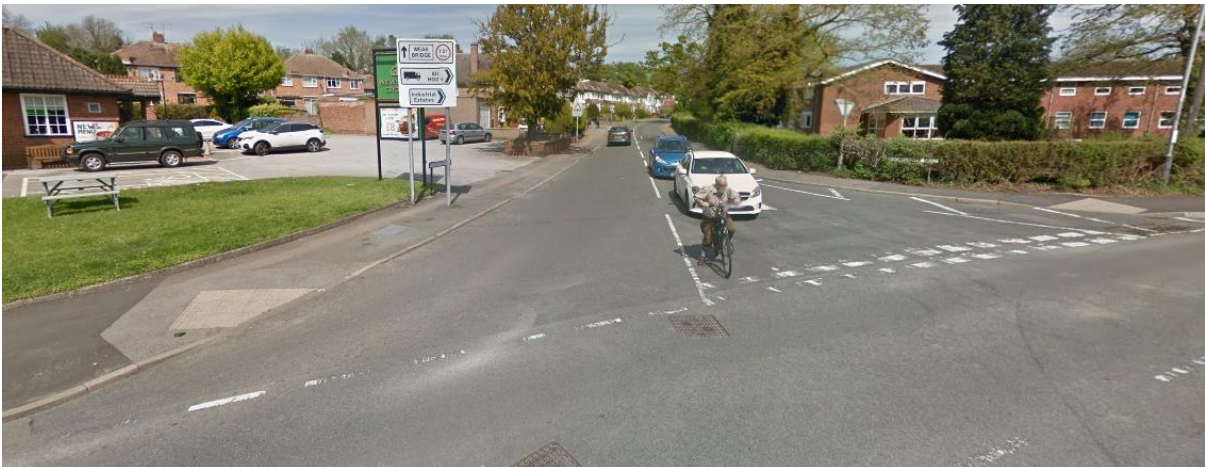
Before Images

The majority of the collisions were due to failure to give way at the crossroad intersection.
