## Section 19 Flood Investigation

Flooding 11<sup>th</sup> June 2023 Wood End, Atherstone

Warwickshire County Council as Lead Local Flood Authority

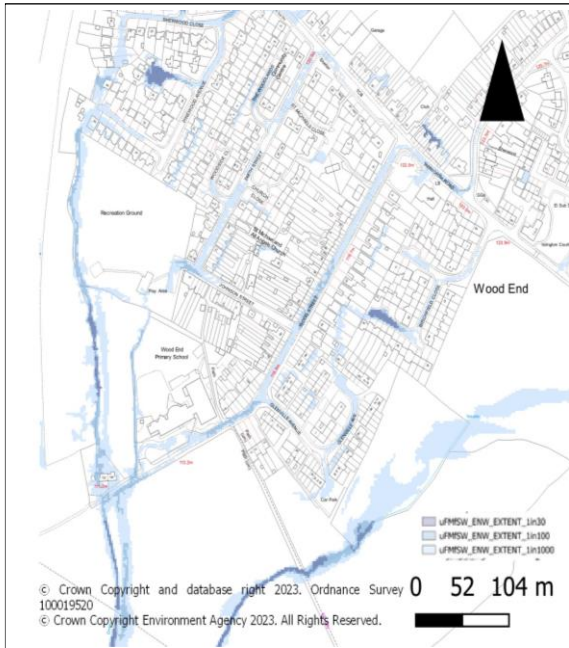
Wood Street/Glenville Avenue is an area of adopted highway which serves as access for many properties and an associated Primary School. A STW combined sewer originates from Tamworth Road and runs beneath Wood Street, past the Primary School before crossing the highway into the adjacent field going southwards towards Hurley. Beneath Glenville Avenue there is an existing foul sewer which flows towards Wood Street and taps into the combined sewer. There is also a surface water sewer which originates from Birchfield Close, flows beneath a number of properties and eventually outfalls into a watercourse at the rear of Glenville Avenue.

North of Wood Street and West of the Primary School there is a series of Ordinary watercourses which convey overland flows as well as acting as a discharge point from the upstream STW surface water sewers. These ordinary watercourses become culverted beneath private land/adoptable highway and discharge into an open watercourse the opposite side of the highway from the primary school.

Two distinct surface water flow paths were noted to have occurred during this event. The primary originated on the higher land on Tamworth Road and proceeded to flow down Wood Street overwhelming the WCC County Highways and STW systems. Tamworth Roads sits with a finished level of 122.0 m with the lowest point of Wood Street sitting at 111.2m. As a result of the intense rainfall event, artificial drainage networks becoming overwhelmed, flows began to back up out of manholes and gullies onto Wood Street. The primary flow path then proceeded to flow down Glenville Avenue and once again resulted in the artificial drainage networks becoming overwhelmed and flows began to back up out of manholes and gullies onto Glenville Avenue.

The secondary flow path originated from the fields to the North of Wood Street and the West of Wood End Primary School via a series of Ordinary Watercourses. Significant flows were observed flowing through these watercourses prior to flowing through a culvert beneath private land/adopted highway. As a result of a combination of overgrown and heavily vegetated watercourses and a potential blockage in the culvert, a further property on Wood Street was internally flooded.

No.	Action	Responsible party	Progress
1	Undertake appropriate channel maintenance	Landowner	Ongoing
2	Consider options to retro-fit Sustainable Drainage Systems (SuDS) on Wood Street and Glenville Avenue	LLFA	Ongoing
3	Ensure that highway cyclic gully cleansing is scheduled at an appropriate interval	WCC Highways	Ongoing
4	Offer advice to residents that have been internally flooded from this event	LLFA	Ongoing
5	Advise resident to consider investigating the presence of a potential blockage of culvert beneath their land and undertaking repairs as appropriate.	LLFA	Complete
6	Remind local landowners of their riparian duties to maintain watercourses	LLFA	Ongoing
7	Reline/patch areas of the sewer networks where defects have been identified	STW	Ongoing
8	Consider installing additional highway drainage along Wood Street and Glenville Avenue	WCC Highways/LLFA	Ongoing
9	Residents to consider the installation of Property Flood Resilience (PFR) measure	Residents	Ongoing
