Report Title:	Stage 2 Road Safety Audit Report
Location:	A429 Coventry Road, Warwick
Date:	14/11/2022
Document reference and revision	RSA3411
RSA Team Leader:	Andy Paul BEng (Hons), MCIHT, HE Cert Comp
RSA Team Member:	Marcus Alford-Longley

- **1.1** This report results from a Stage 2 Road Safety Audit on a proposed off-carriageway cycle route scheme, along a section of the A429 Coventry Road, Warwick, Warwickshire. The report was requested by Uzayr Butt, Design Services, Warwickshire County Council.

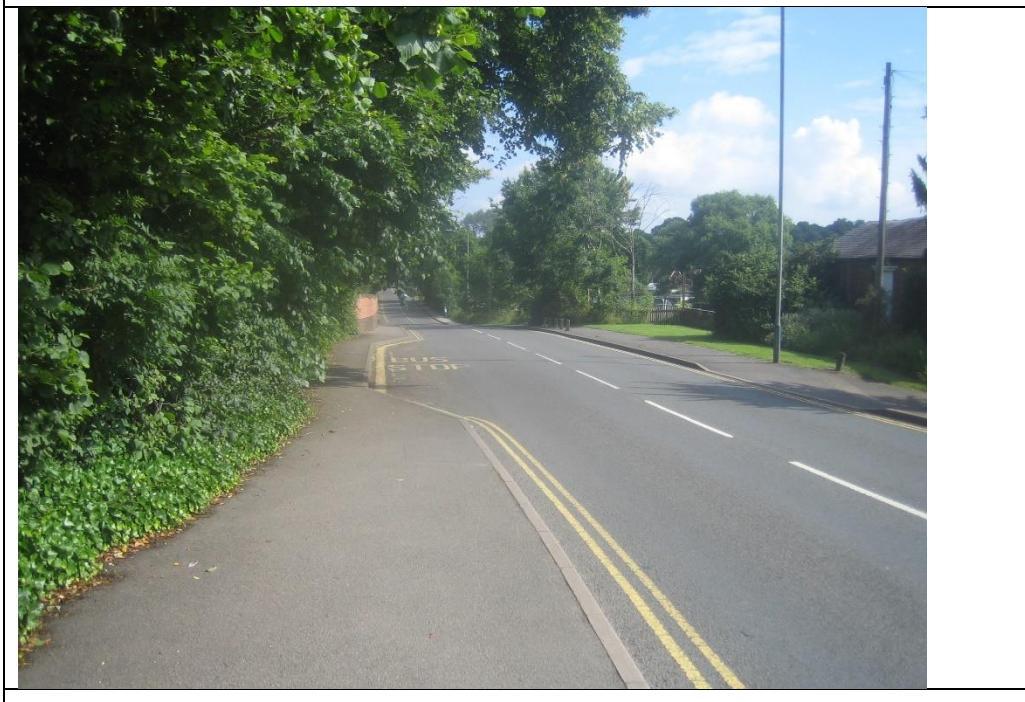
5.2 PROBLEM	
Location: Northbound approach to Grand Union Canal Bridge	
Summary: Potential injury to cyclists

On the northbound approach to the canal bridge, there are currently a number of low hanging trees over the existing footway, which could cause injury to cyclists travelling along the cycleway.

Recommendation:

The tree overhang should be cut back so that it is raised to a height of at least 2.5m.

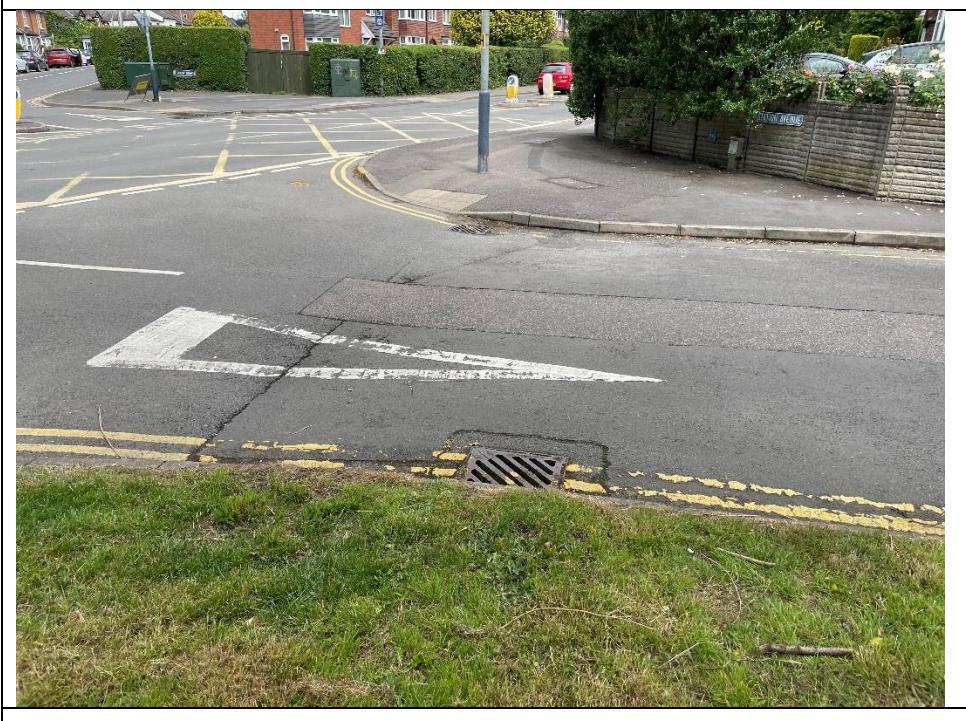
5.3 PROBLEM		
Location: Coventry Road east side at Station Road		
Summary: Potential hazards for pedestrians and cyclists

At the junction with Station Road, there are several existing issues that could be hazardous for pedestrians and cyclists, as follows:

- There are two existing road gullies at the junction, one of which could be beneath the proposed road hump at the junction, which could result in flooding in the carriageway and lead to pedestrian slips.
- There is an existing street lighting column that could be in the path of cyclists or pedestrians approaching or exiting the proposed new crossing point, which could result in cyclists or pedestrians colliding with the column, particularly during hours of darkness.
- At the proposed inset cycle priority crossing, kerb upstands are not clear at points on the road hump remote from the tactile paving crossing. Some cyclists may choose to cross the road hump in a "straight line" away from the inset tactile crossing point which, if there is a relatively high kerb upstand, could result in them becoming unseated and lead to injury.

Recommendation:

Road gullies should be relocated at the bottom of road hump ramps, the lighting column should be relocated, and kerb upstands away from the inset crossing point should be set at the minimum that will assist visually impaired pedestrians but not present a hazard for cyclists.

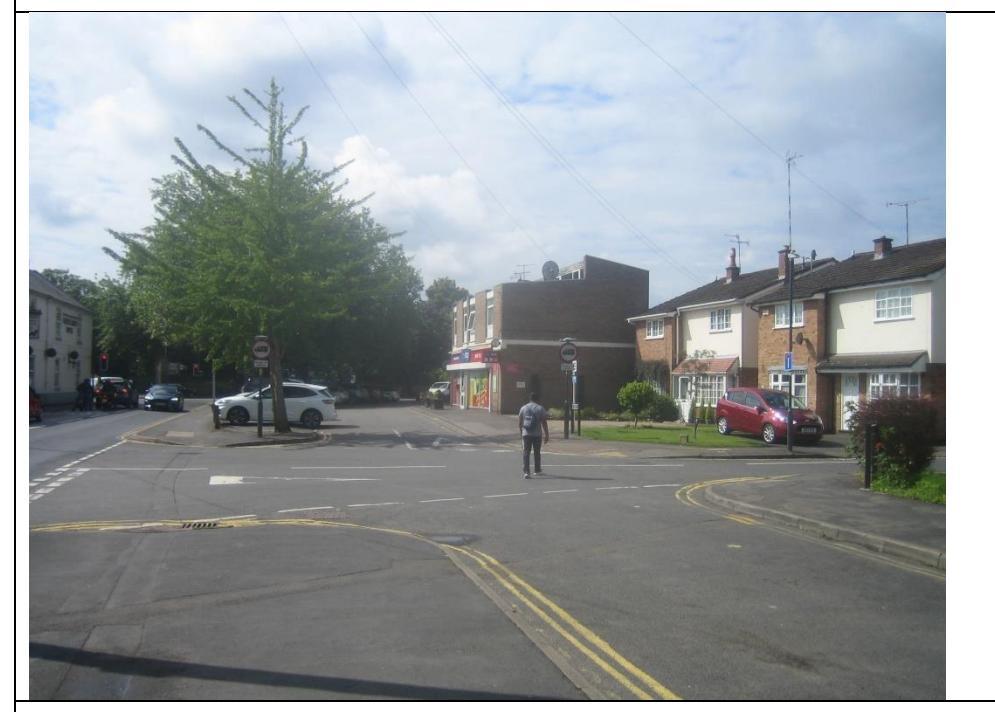
5.4 PROBLEM	
Location: Junction with The Paddocks	
Summary: Potential pedestrian / vehicle conflict

At the junction with The Paddocks, the drawings do not show any tactile paving across the junction. This could lead to a pedestrian stepping out into the junction without realising, and lead to conflict between pedestrians and vehicles entering or emerging from The Paddocks.

Recommendation:

Tactile paving should be provided across the junction in line with guidance. This may require the relocation of a road gully currently on the likely pedestrian desire line.
