**WORKS RE-COMMENCED AFTER CHRISTMAS SHUT
DOWN – on 05-JAN-23**

**Footway & carriageway works on the Bermuda
Bridge Eastern embankment approach**

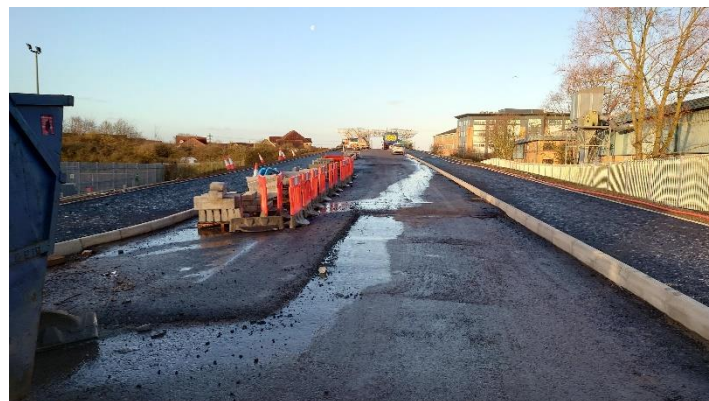
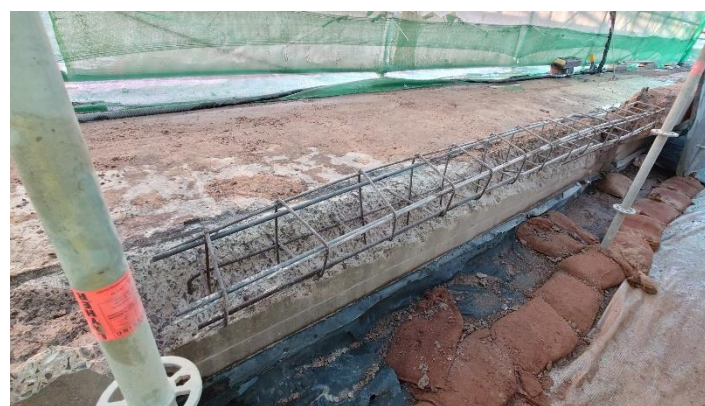
Footways & carriageway tarmacking on both southern & northern sides of the eastern approach to Bermuda Bridge is being completed in readiness for final surface course.

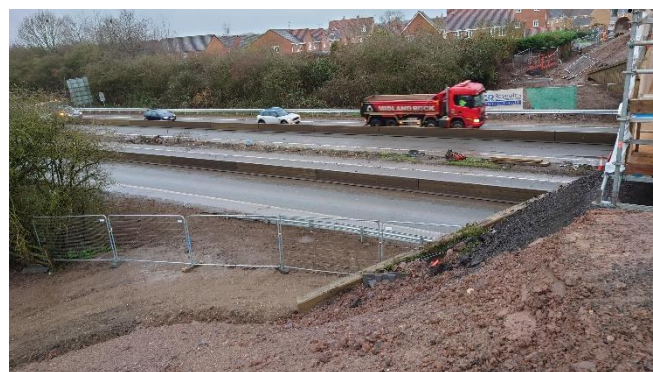
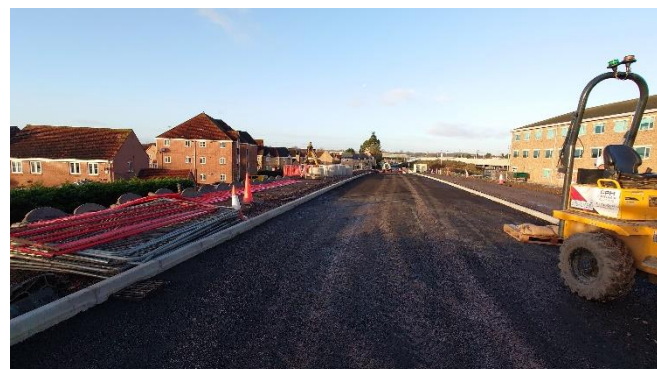
**Hydro-demolition works on the Bermuda Bridge
edge beam replacement**

Hydro-demolition works have commenced to remove the concrete to the existing Bermuda Bridge edge beam. The exposed existing reinforcement is in good condition. The hydro-demolition works are planned to continue until end of January 2023, after which new reinforcement and concrete will be installed to reinstate the edge beam for new safety barrier.

Safety Barrier works continued along A444 Griff Way

Safety barrier installation along the A444 Griff Way central reservation has continued on the approaches to Bermuda bridge and is planned to be completed by 21st January 2023, when all traffic management along the A444 Griff Way will be removed.

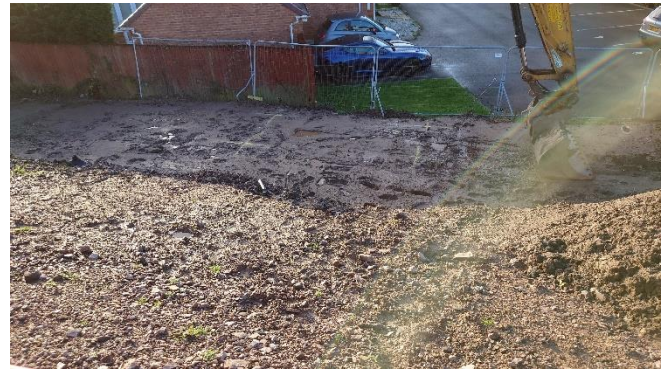
**Footway & carriageway works on the Bermuda
Bridge Western embankment approach**

Footways & carriageway tarmacking on both southern & northern sides of the western approach to Bermuda Bridge is being completed in readiness for final surface course. Carriageway base course protected against site plant damage.

Gas Vent Trench Exposure Works

Continuing survey of the existing Gas Vent Trench (GVT) which exists adjacent to the housing developments in the vicinity of The Bridleway and is required to be extended to new ground levels when works are completed.

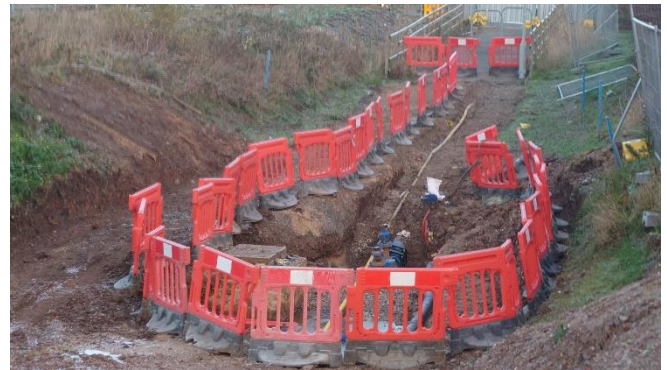
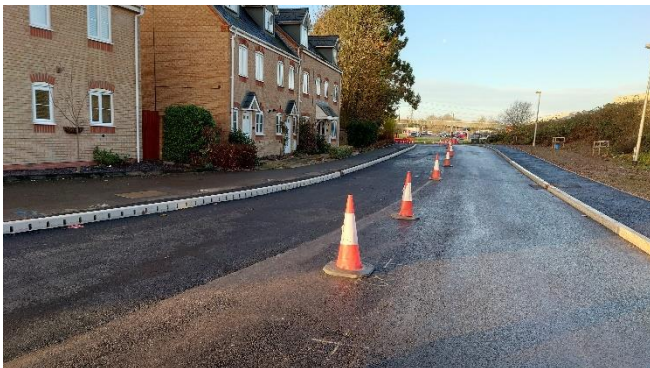
Existing Gas and Water Main Protection Works

An existing gas and water mains will need to be protected before work can commence along the northside of The Bridleway. Cadent and STW are to attend site and agree on way forward. Additional trial holes were undertaken to establish depth of existing water main were completed for the STW site visit.
