Queensway/Kingsway, Leamington Casualty Reduction Scheme Overview

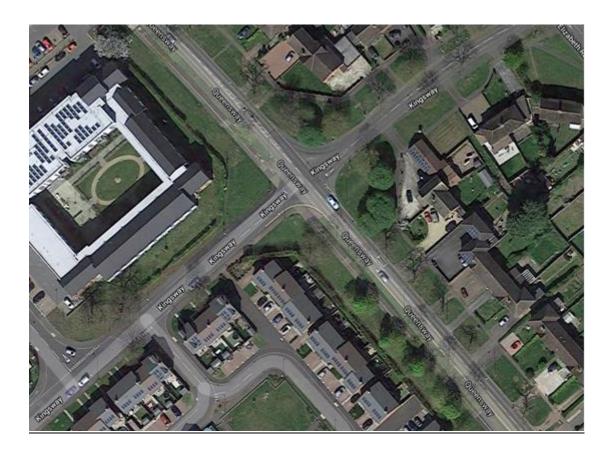
The crossroads junction subject to this scheme is the Queensway (main road) at its junction with Kingsway (side road) in Leamington Spa.

The Queensway is a single carriageway, two-way road running from north-west to south-east. The speed limit is 30mph, and there is a pedestrian refuge island crossing before the junction when heading south-east. The Queensway is an urban area, with surrounding residential estates. Speed cushions are present along the stretch of this road.

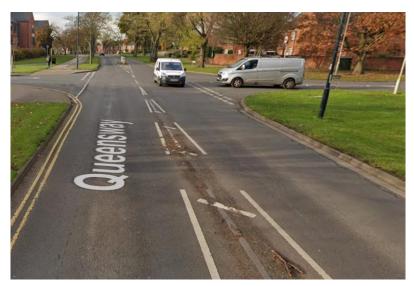
BEFORE

(Travelling North Bound)

Queensway Road before scheme had no speed calming measures at the junction where vehicles already struggled to gain access from Kingsway Road, resulting in failure to give way collisions.

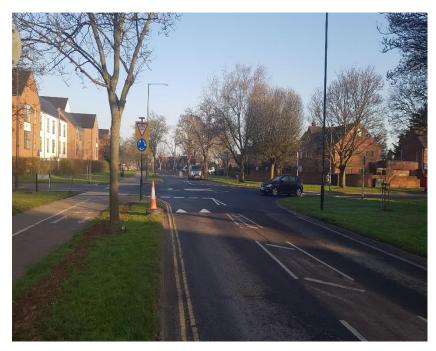
(AFTER)

Queensway Road travelling north bound, now has a raised table on approach to the junction, which is accompanied by illuminated give way road signs and road markings.

Advanced mini roundabout warning signs are also located 100 yards of each junctions.

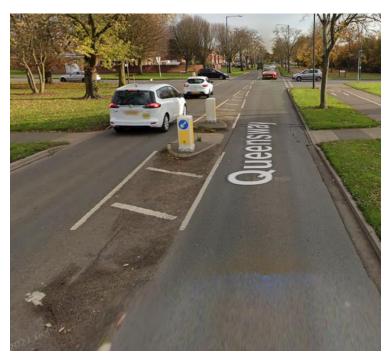
(BEFORE)

(Travelling Southbound)

Queensway road before scheme implemented, did not have a raised table which meant speeds were considerably higher in approach to junction.

Also, there was a pedestrian crossing facility in close proximity to the junction which had no speed calming measure on approach to its location.

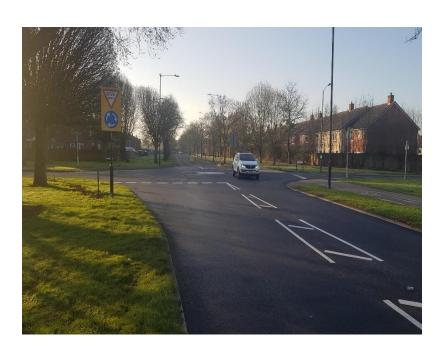
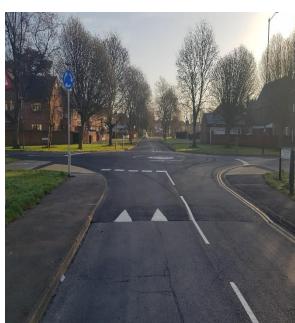
(AFTER)

Approach now benefits from raised table assisting pedestrian crossing points, which makes it a far safer crossing location.

Clear Give Way Signs with illumination allow vehicles adequate time to stop for the new mini roundabout junction layout.

Vehicles from Kingsway can now access on to Queensway far easier, which will have a significant impact on the number of failures to give way collisions occurring at this location.

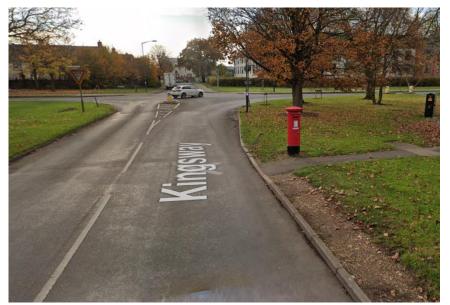
(BEFORE)

Kingsway Road, before scheme implementation had no raised table on approach, signage was dated, and there was no mini roundabout which meant access on to Queensway was difficult.

Driver frustration in not being able to access on to Queensway led to drivers taking risks and leading to failure to give way collisions.

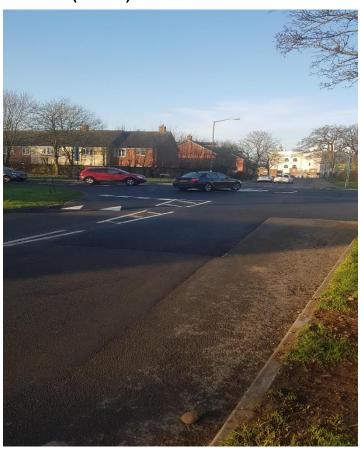
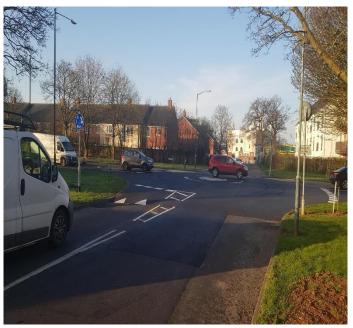
(AFTER)

Kingsway junction now benefits from mini roundabout installation, which allows vehicles to access Queensway in a more driver friendly manner. Raised table on approach to the junction also allows vehicle speeds to be controlled, as well as clear illuminated signage highlighting the new junction layout.

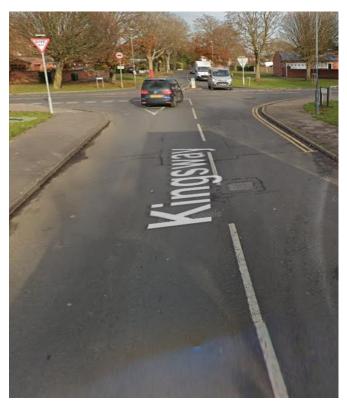
(BEFORE)

Kingsway Road (temple side) prior to scheme did not benefit from mini roundabout road layout which again meant high number of vehicles which use this road could not access on to Queens Road during peak times.

Signs were also not illuminated on approach and road marking give way lines were beginning to wear.

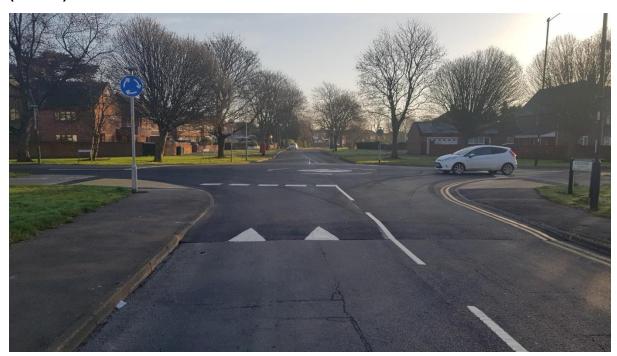
(AFTER)

Kingsway Road (Temple side) now benefits from an extended raised table approach to the junction, this has significant benefits in that speeds are controlled on approach to the junction which means vehicle movements facilitating the junction will be far better controlled.

There is also a heavily used crossing point here, the raised table will mean that as vehicle speeds are significantly reduced at the junction cyclist and pedestrians will feel safer crossing at this location.

The location has had new signage with illumination installed allowing vehicles to clearly identity the new road layout ahead.

Early observation of the scheme has highlighted that traffic controls are far better at this location, with vehicles now confidently able to access Queensway Road as well as vehicles also being able to turn in to Kingsway far easier without holding up traffic on Queensway Road.
